**RESEARCH INTO THE PERFORMANCE OF  
WATER TANKS IN BUSHFIRE  
-Bushfire CRC Project D1**

**R. Blanchi, J.E. Leonard, N. White, A. Sargeant, A. Bicknell, S Andersson  
CSIRO – Sustainable Ecosystems (CSE)  
Urban Systems Program**

USP2007/014

December 2007

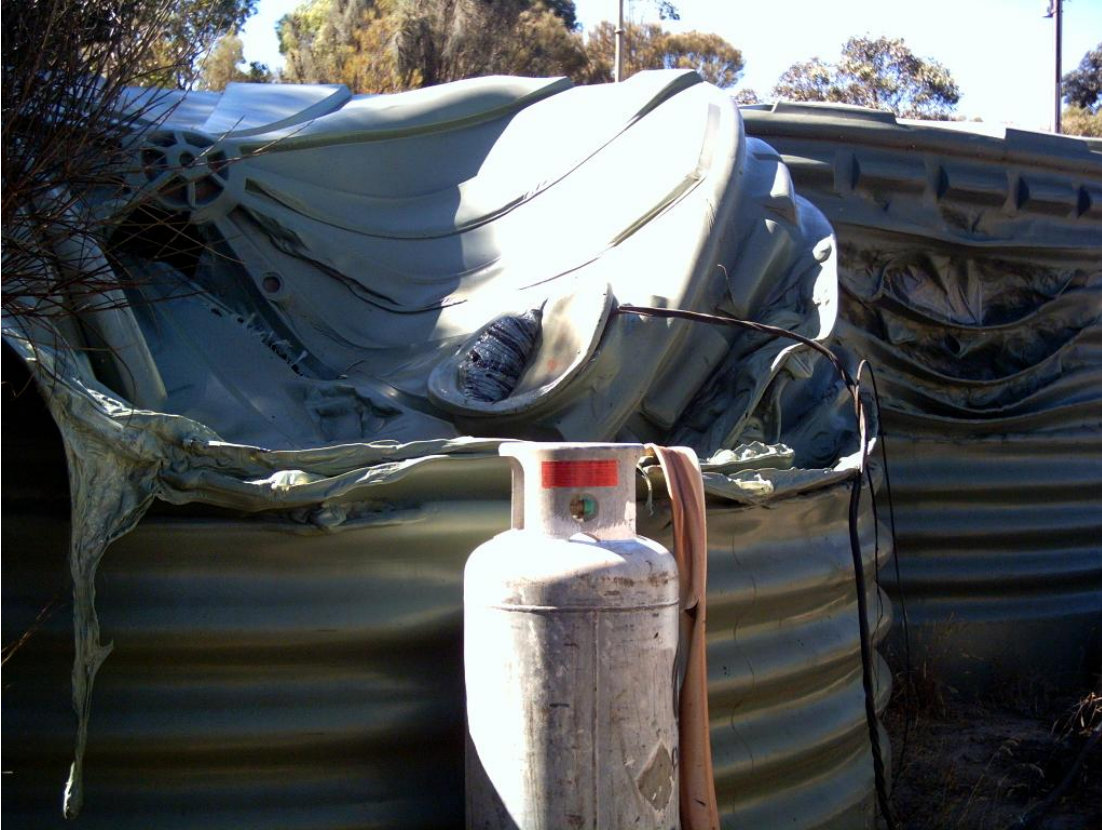
**Figure 1 Example of water tank damaged, Eyre Peninsula**

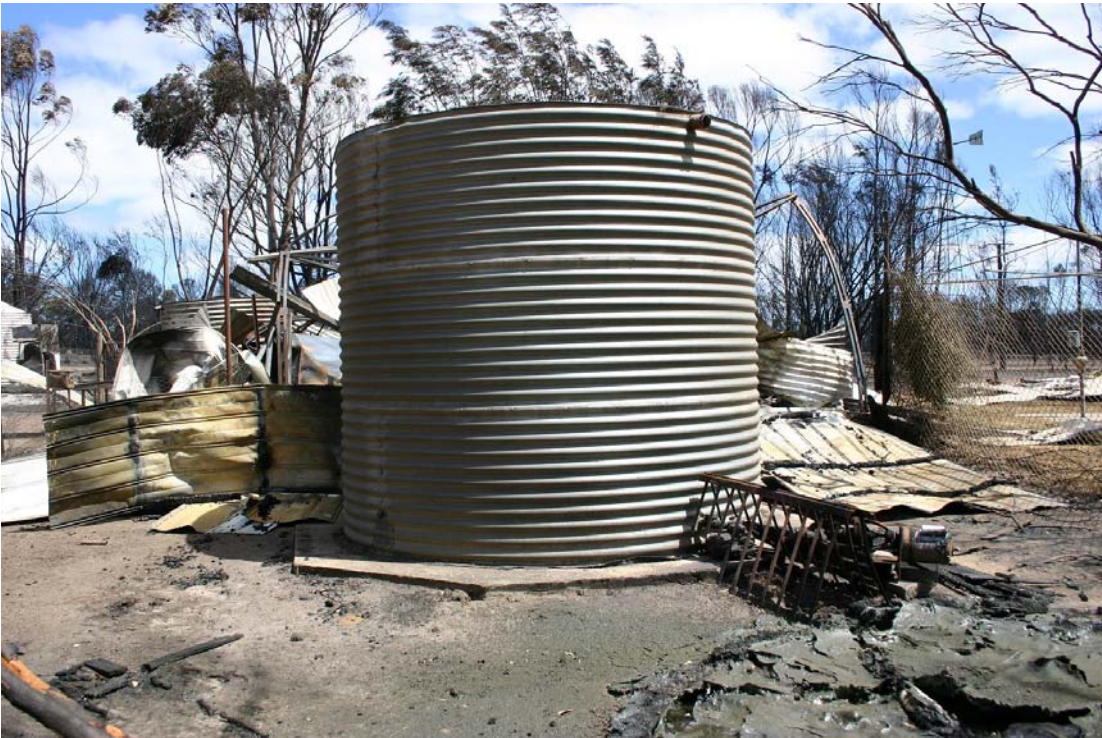
**Figure 2 Example of metal water tank withstanding adjacent structure fire, Eyre Peninsula.**

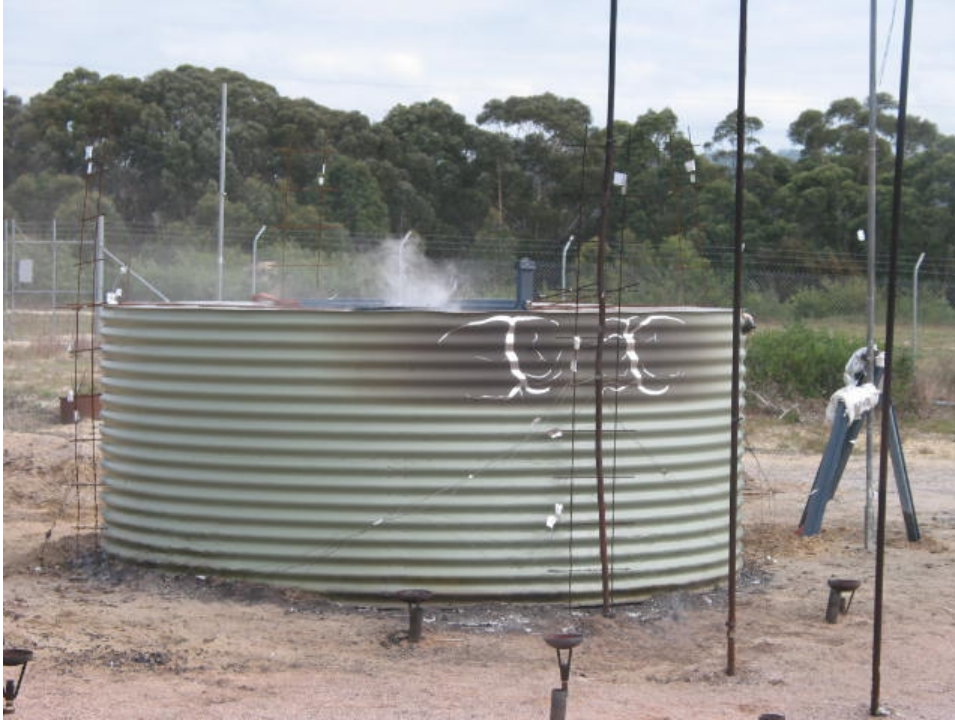
The surface of the tank was scorched, the polymer coating on the inside of the tank above the waterline is heat affected. The tank maintained its ability to hold water during and after the exposure (see Figure 4). This figure and the surface temperatures measured illustrates how these water tanks are more heat effected above the water level than below it due to the body of water acting as a heat sink.

**Figure 4 Experiment 1 - Leaf litter ignited and pre-radiation on metal coated water tank**

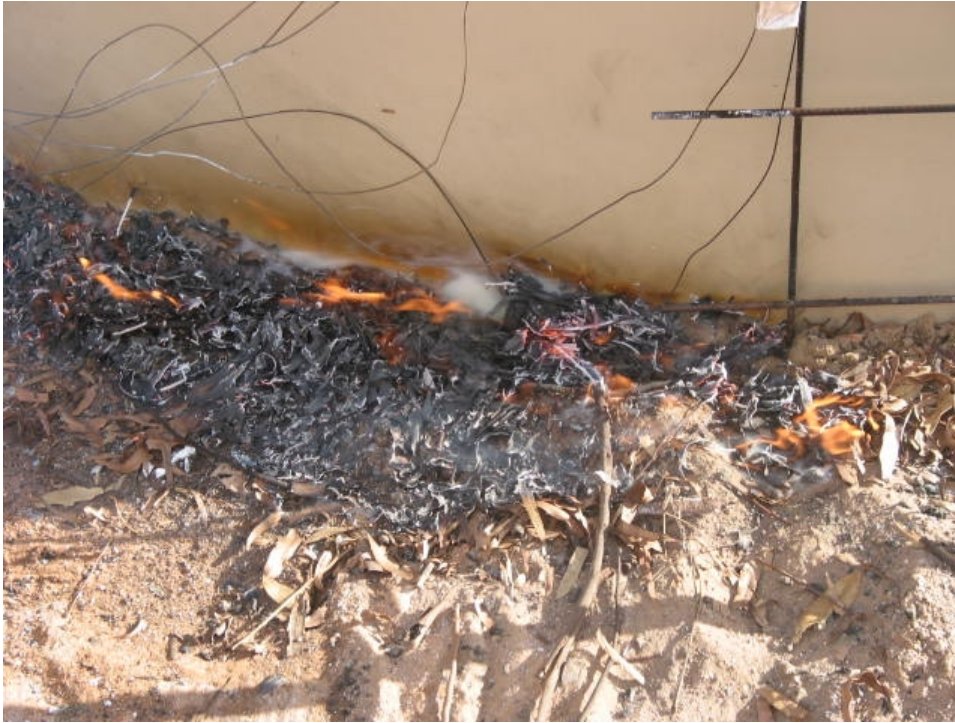
The flaming of the litter caused a few scorches on the bottom of the tank (see Figure 8). No leaks were observed and the integrity of the tank was maintained. Some consumption and melting of polyethylene around the base of the tank was observed but appeared to be insufficient to cause a weakening of the tank or leaking.

**Figure 8 Experiment 4 - Leaf litter exposure on polyethylene tank**

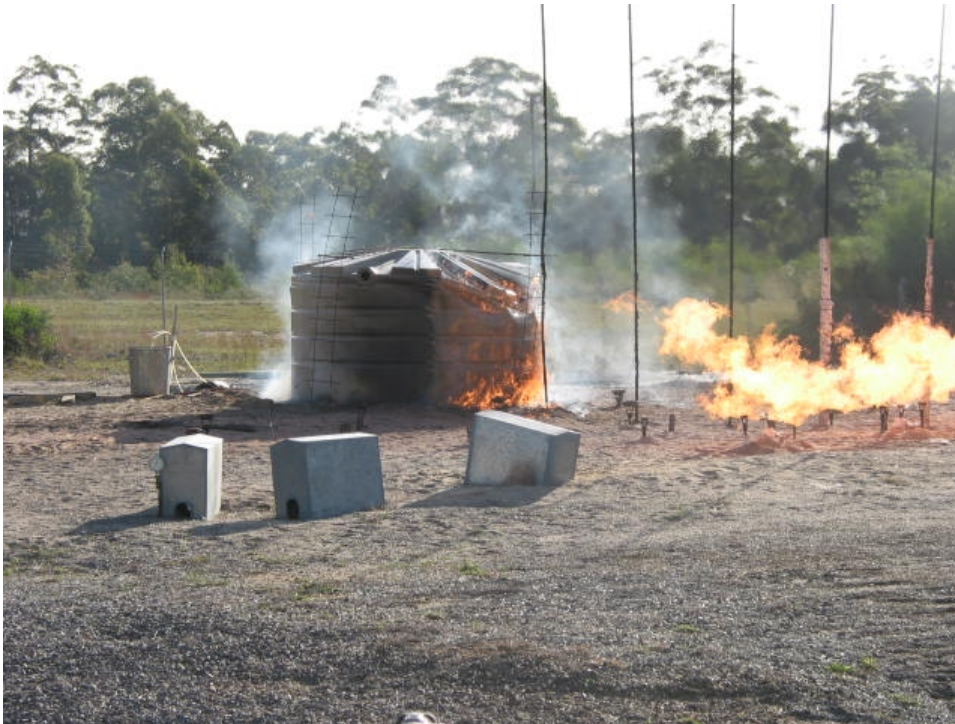
Smouldering on the front face of the tank is observed during early stage of radiation exposure. The bottom front began flaming after 7:00 and by 7:30 the entire front surface of the tank was involved in flame (see Figure 10). Flaming decreased at about 8:00 and ceased as burners are turned off. Temperatures of approximately 150°C were measured at the front exterior surface both above and below the water level just prior to flaming at these points. The experiment concluded with the top of the tank melted and deformed to the level of water, small flame still persisting on the top of the tank. There was water leaking out of the base of the tank at approximately 3 litres per minute, these leaks occurred at points where the tank had softened and expanded around its base by approximately 150 mm and contacted the instrument support rigging. Figure 11 below shows this extent of damage and leaking.

**Figure 10 Experiment 5 - Pre-radiation exposure on polyethylene tank**

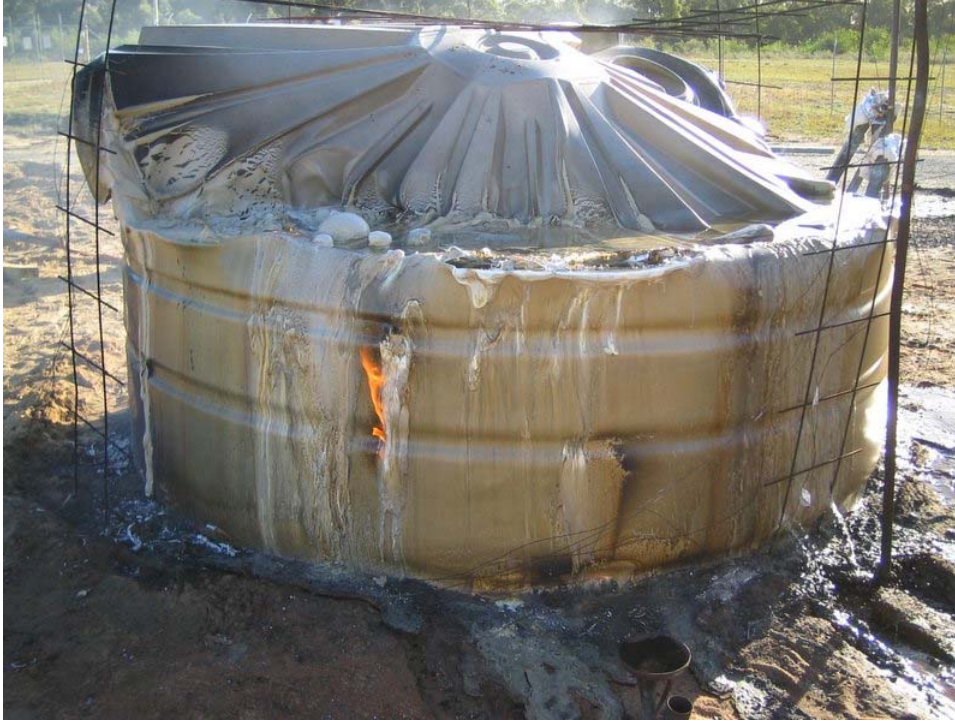
From the bushfire passage exposure further melting and propagation of leaks without complete structure failure was observed. In the front face the outer surface below the level of water had softened and yielded further (see Figure 12). Although the tank still held water it was severely damaged and would require replacement.

Figure 12 Experiment 6 - Structure exposure on polyethylene tank

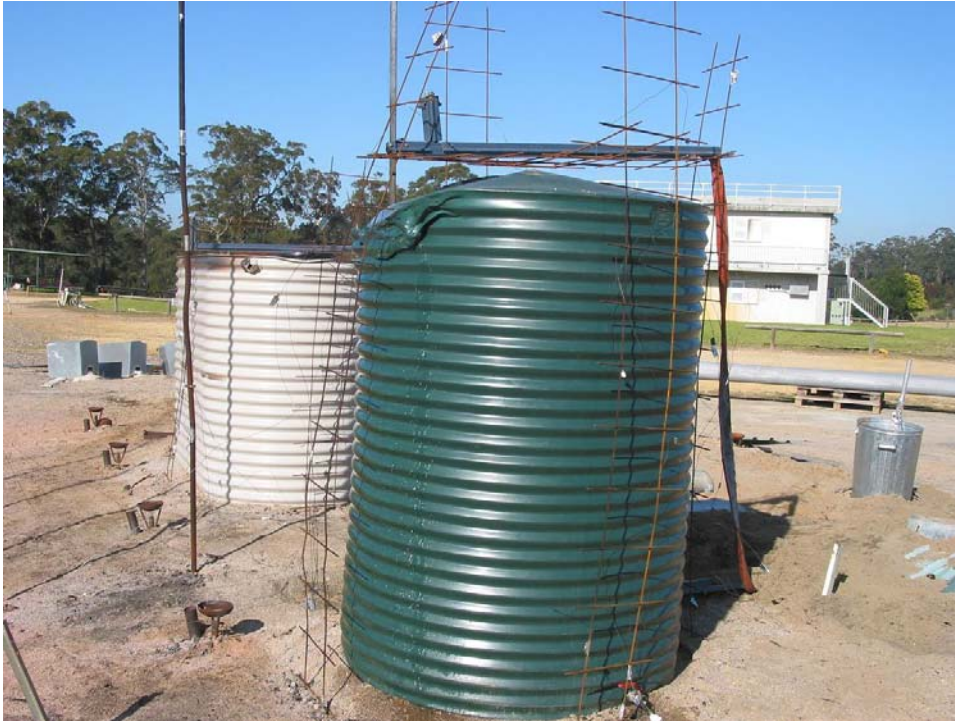
After 4 minutes and 30 seconds white smoke became visible from the metal tank (white plastic coating). After 6 minutes and 48 seconds smoke rose out of the polyethylene tank (dark green), and the top of the tank started to melt (see Figure 18). At 9:30 the pre-radiation burners were turned off and the experiment ceased. Tank 4 leaked from the melted region at the top of the tank and bulged slightly at the base at the front face. Tank 2 did not leak.

Figure 18 Experiment 12 - Pre-radiation exposure on polyethylene and metal tank

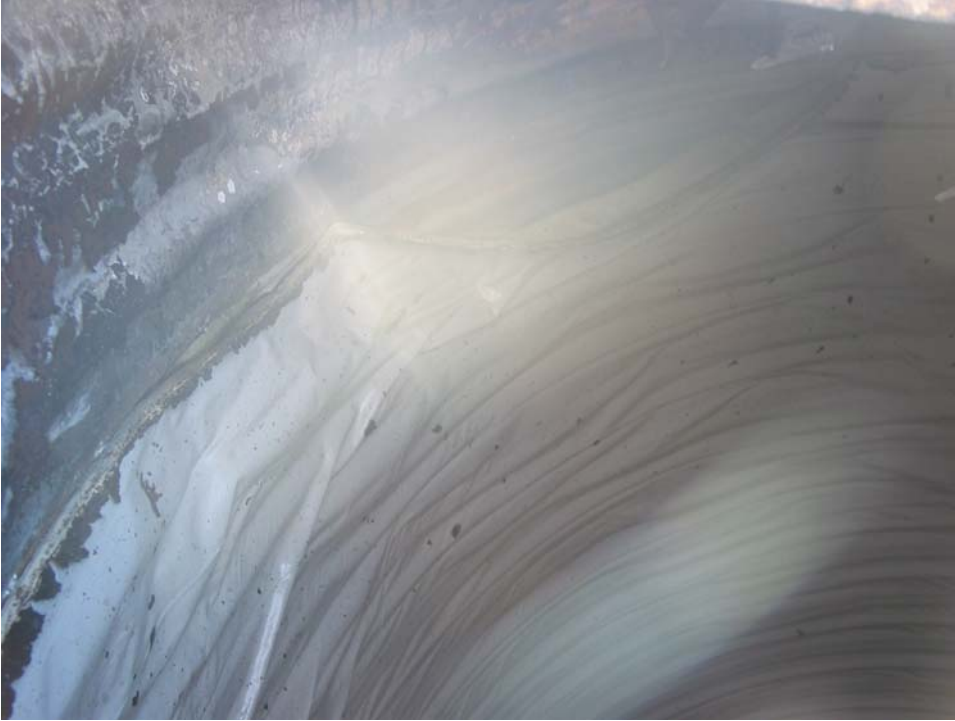
The front face of the tank was scorched, with minor leaks of approximately 0.3 litres per minute (see Figure 27). The liner inside the tank is melted and damaged above the water line with some de-lamination having occurring below the waterline also (see Figure 26).

**Figure 26 Liner inside tank 7**

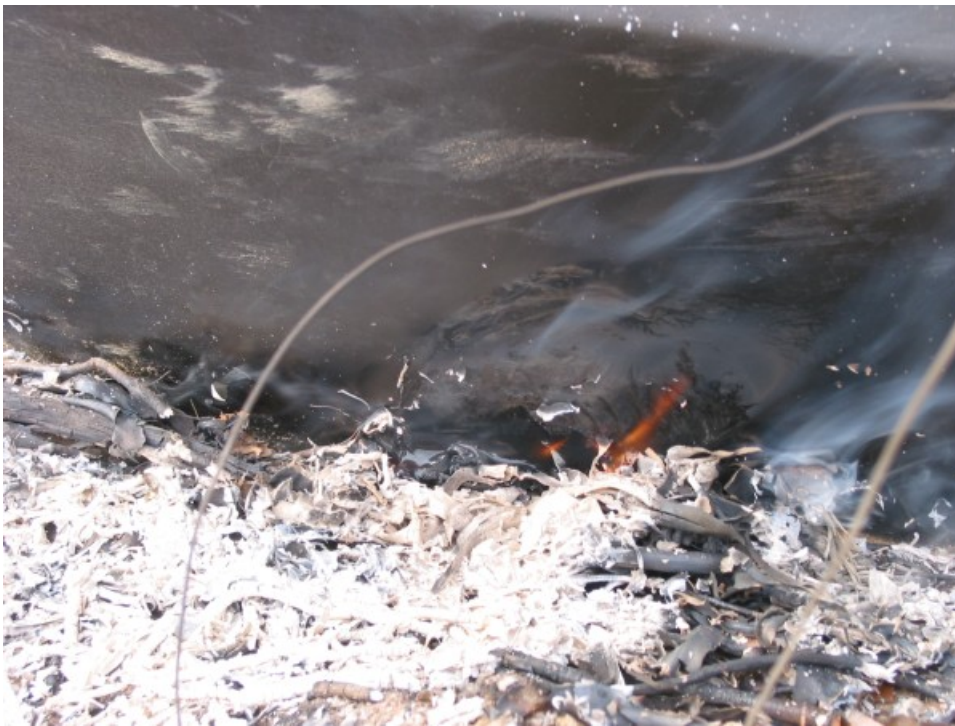
No penetration of the tank occurred and polyethylene tank material became involved in a number of areas around the tanks base, the flame persisted around the tank base for 23:30 (see Figure 28). It is interesting to speculate whether different weather conditions could allow these small flames to persist longer and cause some tank leakage.

**Figure 28 Experiment 18 - Leaf litter ignited exposure on polyethylene tank**

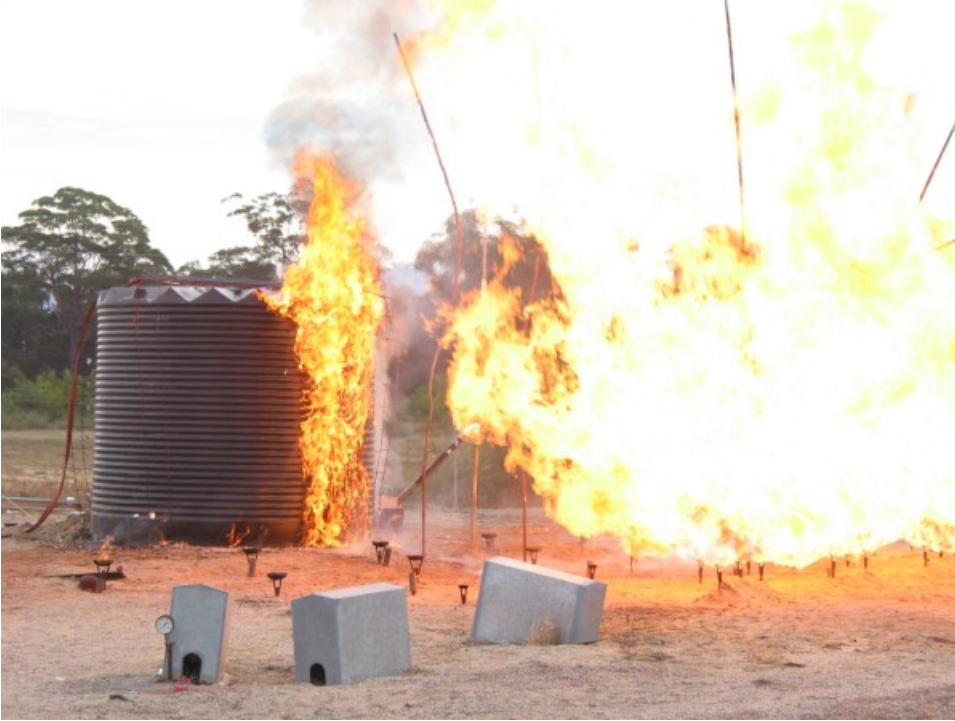
Small flames started from the bottom of the tank and then spread to involve the entire front of the tank by 7 minutes (see Figure 29 and 30). The flames on the front reduced to small flames around the top rim of the tank when the burners were reduced. The top of the tank above the water level melted in part and drooped to the waterline (see figure 31). There was no significant leakage of water.

**Figure 30 Experiment 19 - pre-radiation exposure**

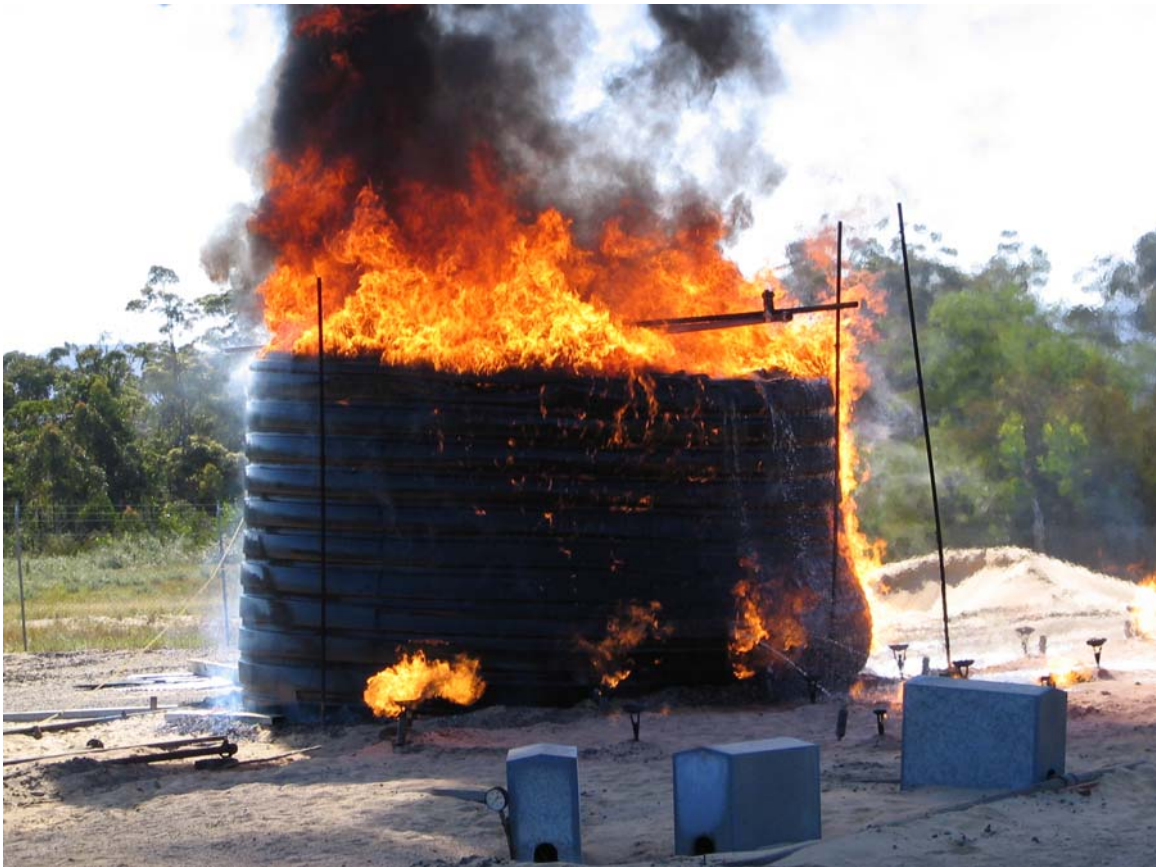
8 minutes into the exposure the tank was still heavily burning mainly from the top, at 8:20 the tank unzipped from the lower half of the tank and emptied itself, see Figure 43.

**Figure 43 Experiment 26 - Pre-radiation and flame exposure on used polyethylene tank**

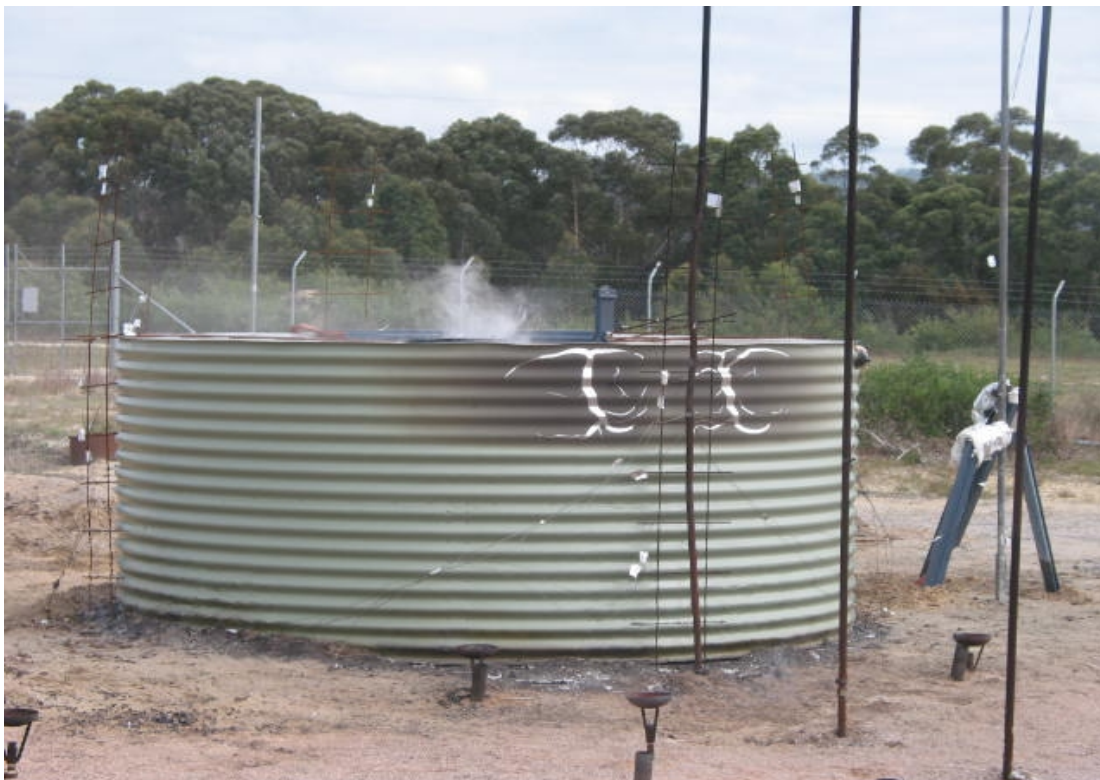
Figure C2 Tank one slight surface damage due to pre radiation.

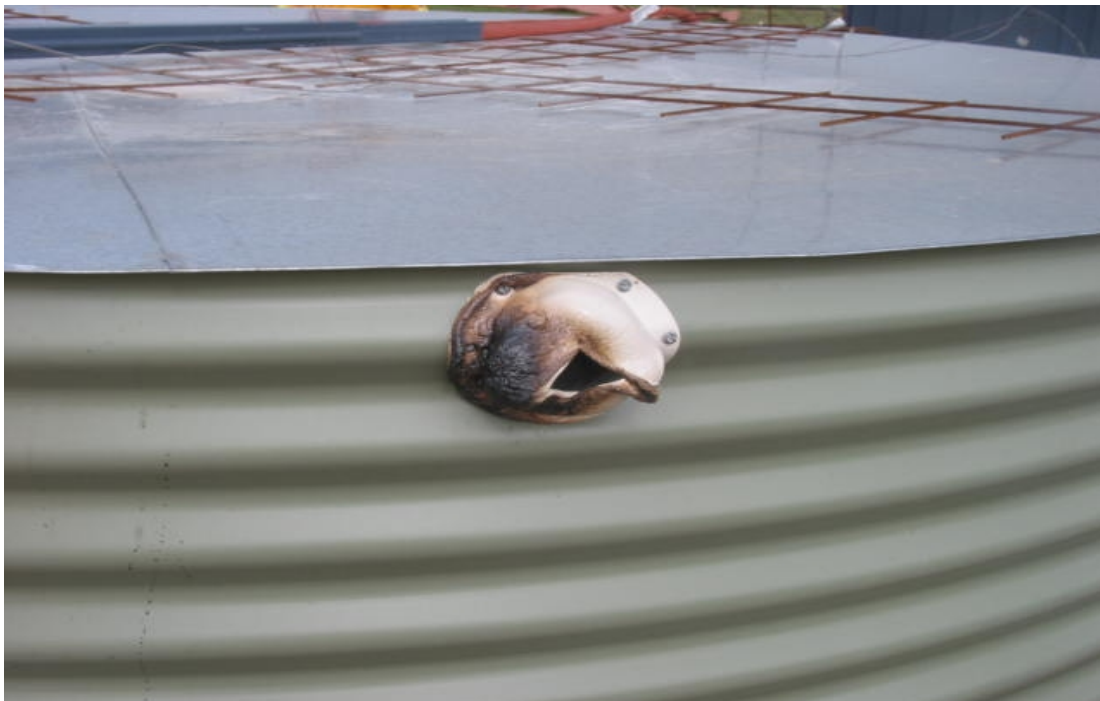
Figure C3 Tank one with damaged over flow outlet.

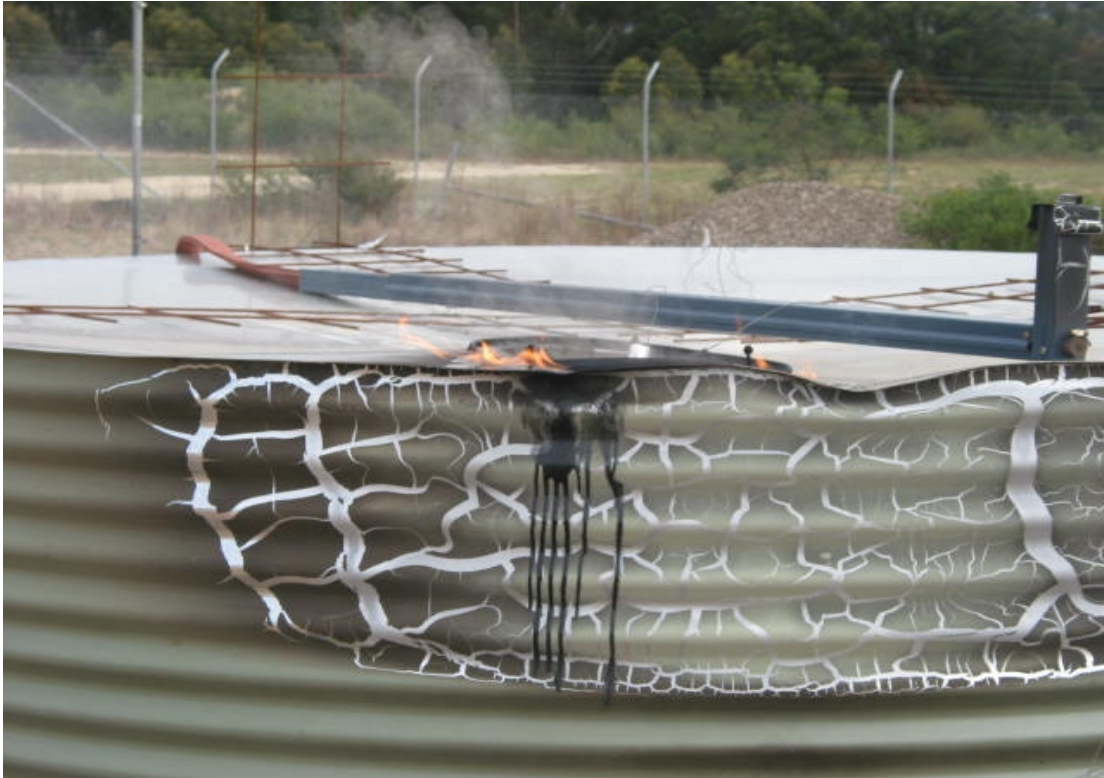
Figure C4 Tank one slight structural damage due to flame exposure

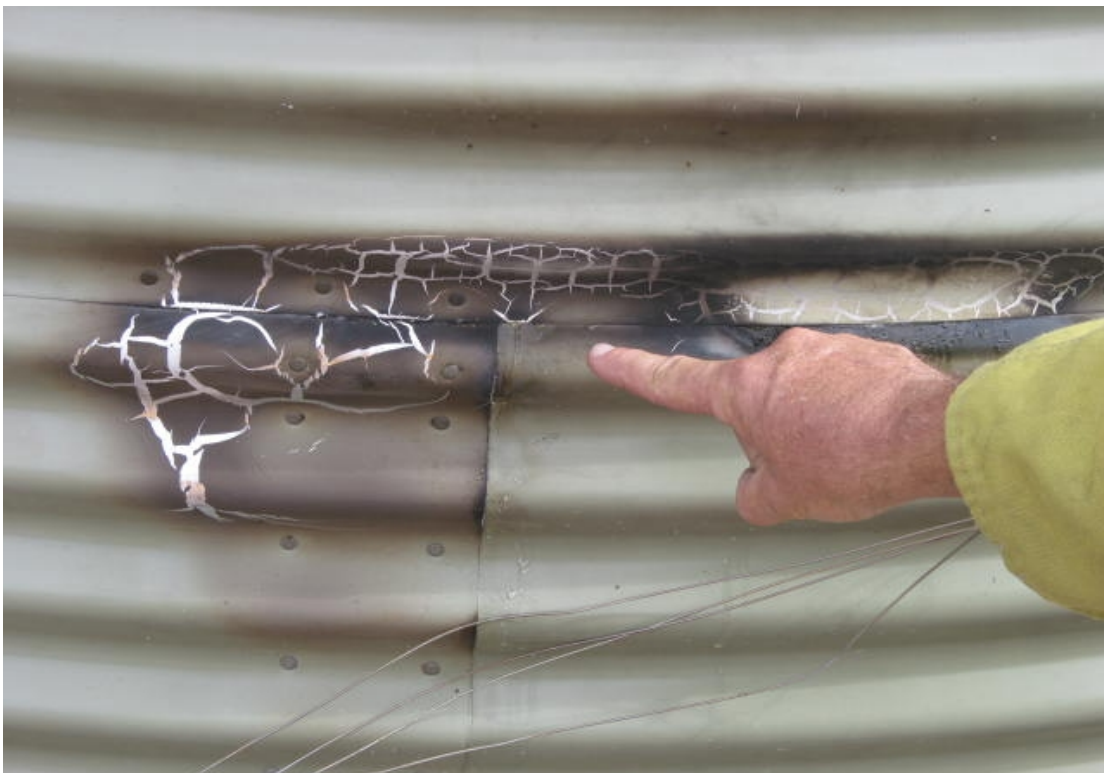
Figure C4 Tank slight damage to joins

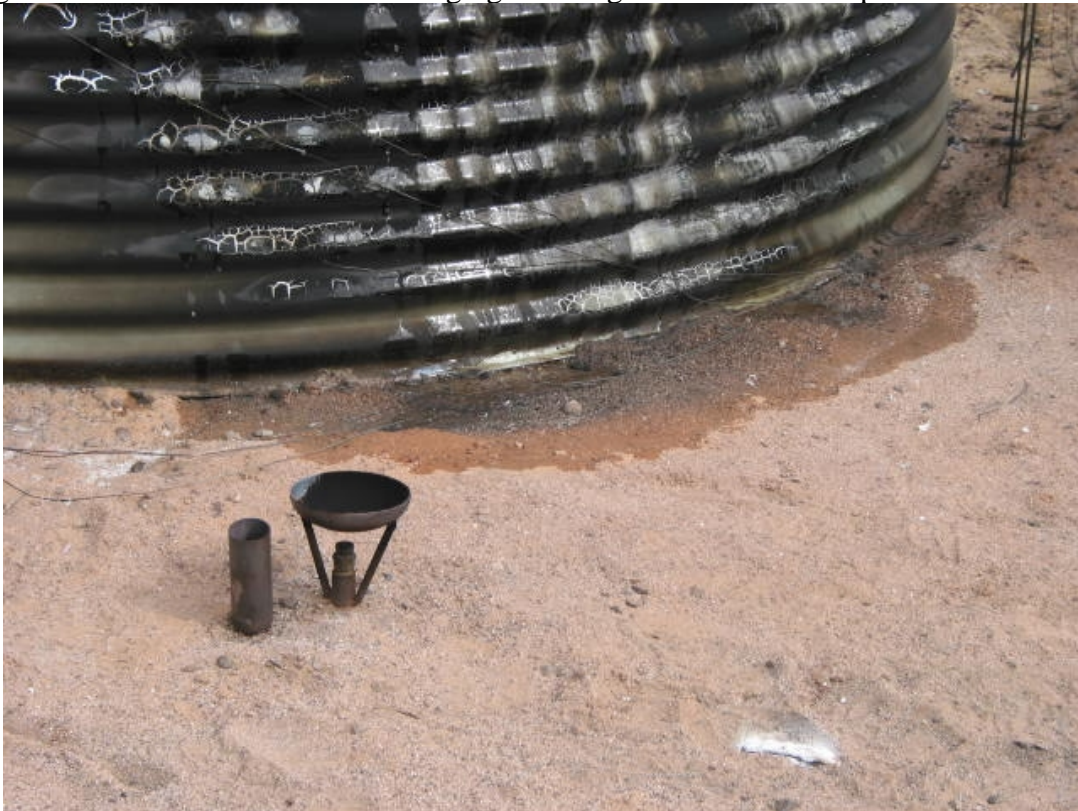
Figure C6 Tank one leaks resulting from severe damage during structural exposure.

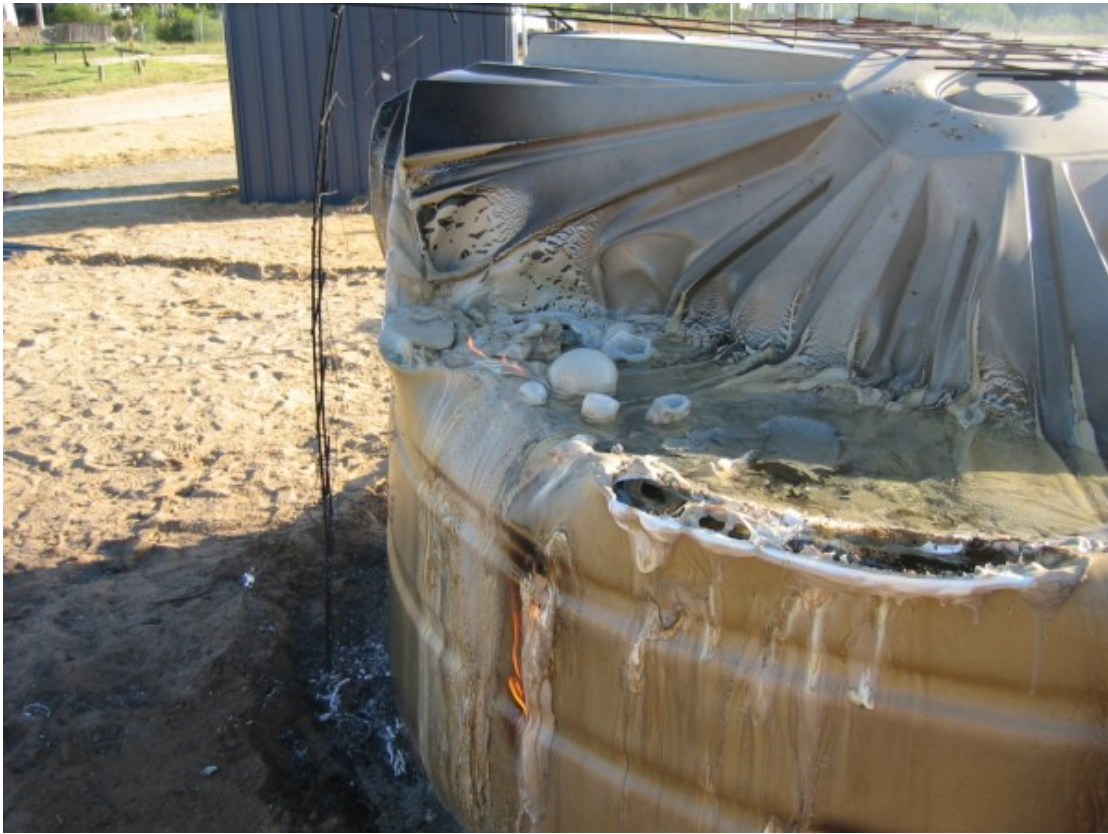
Figure C11 Tank six server structural damage down to water level as a result of per radiation exposure.

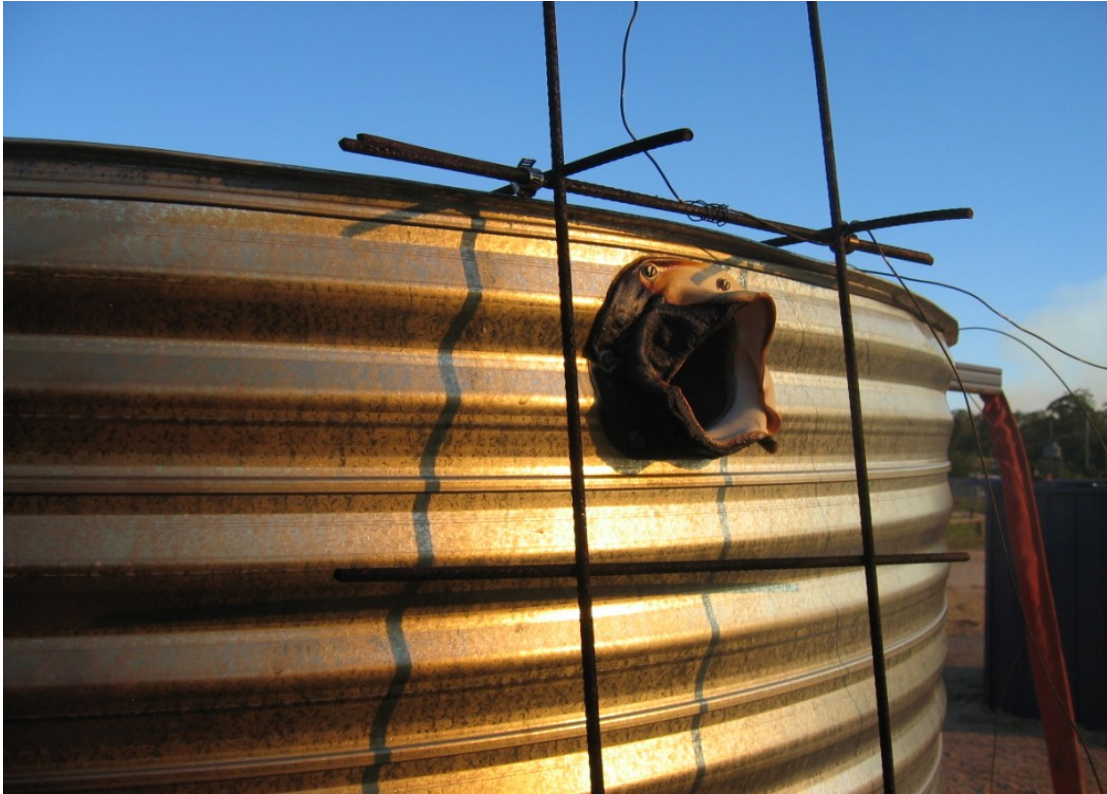
Figure C18 Tank three overflow outlet damage.

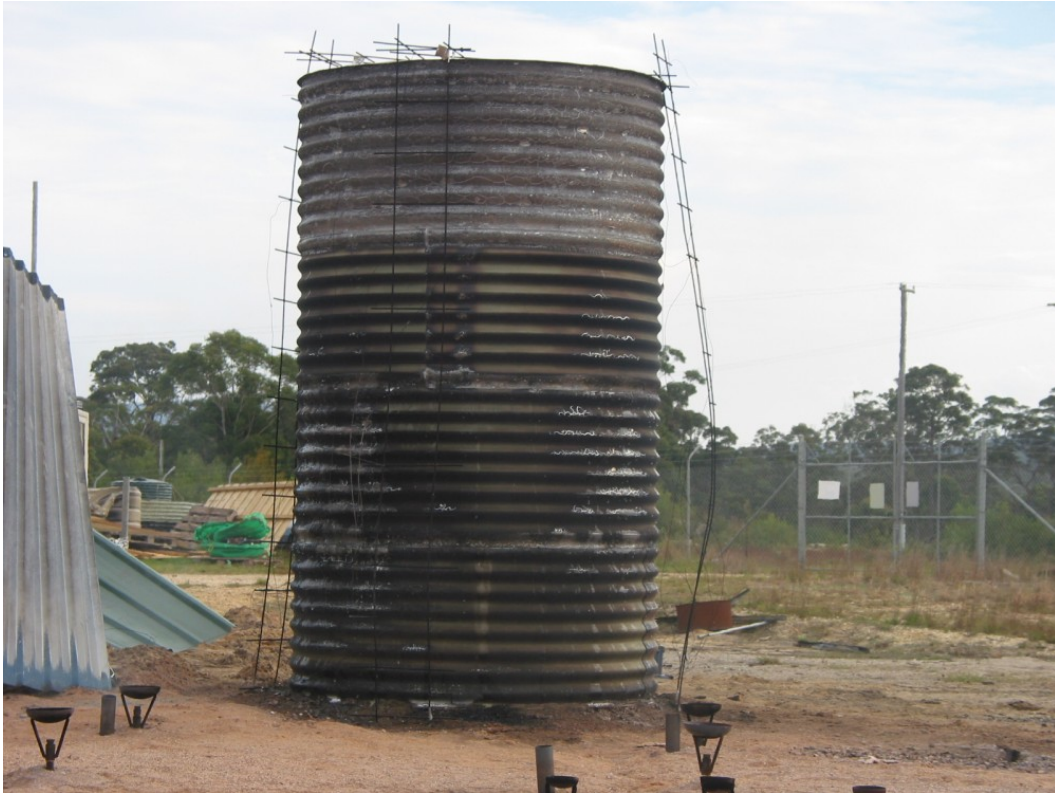
Figure C25 Tank three severe damage resulting from structural exposure.

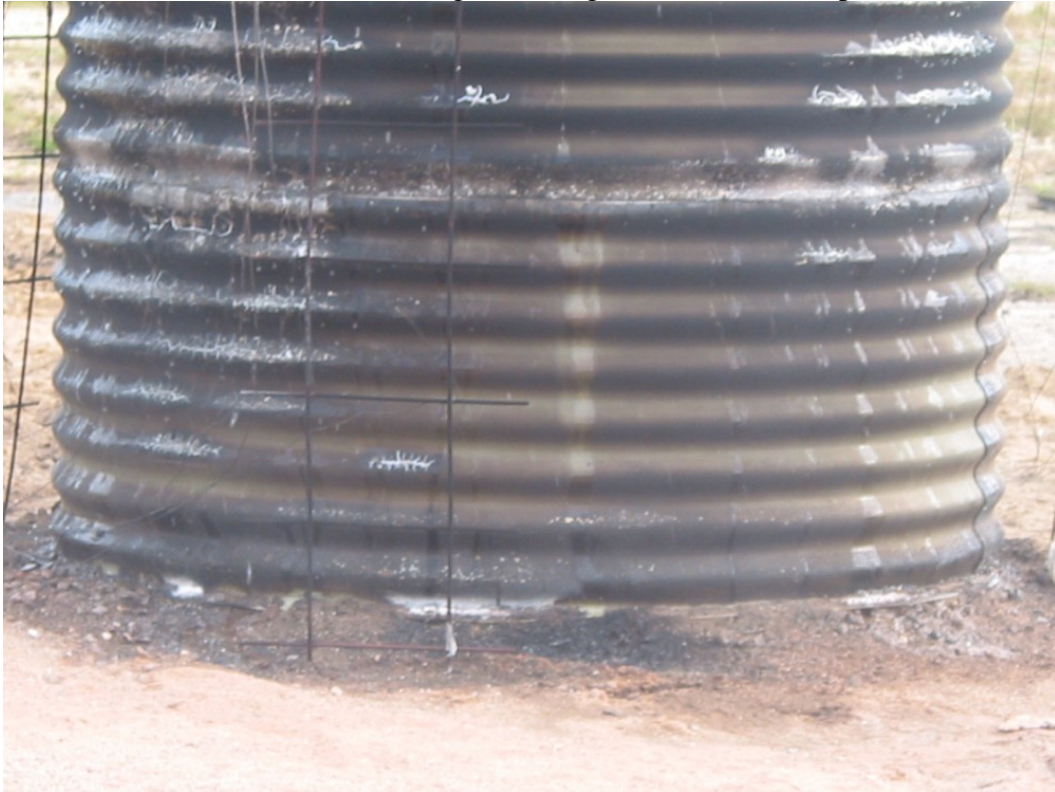
Figure C25 Tank three severe damage resulting from structural exposure.

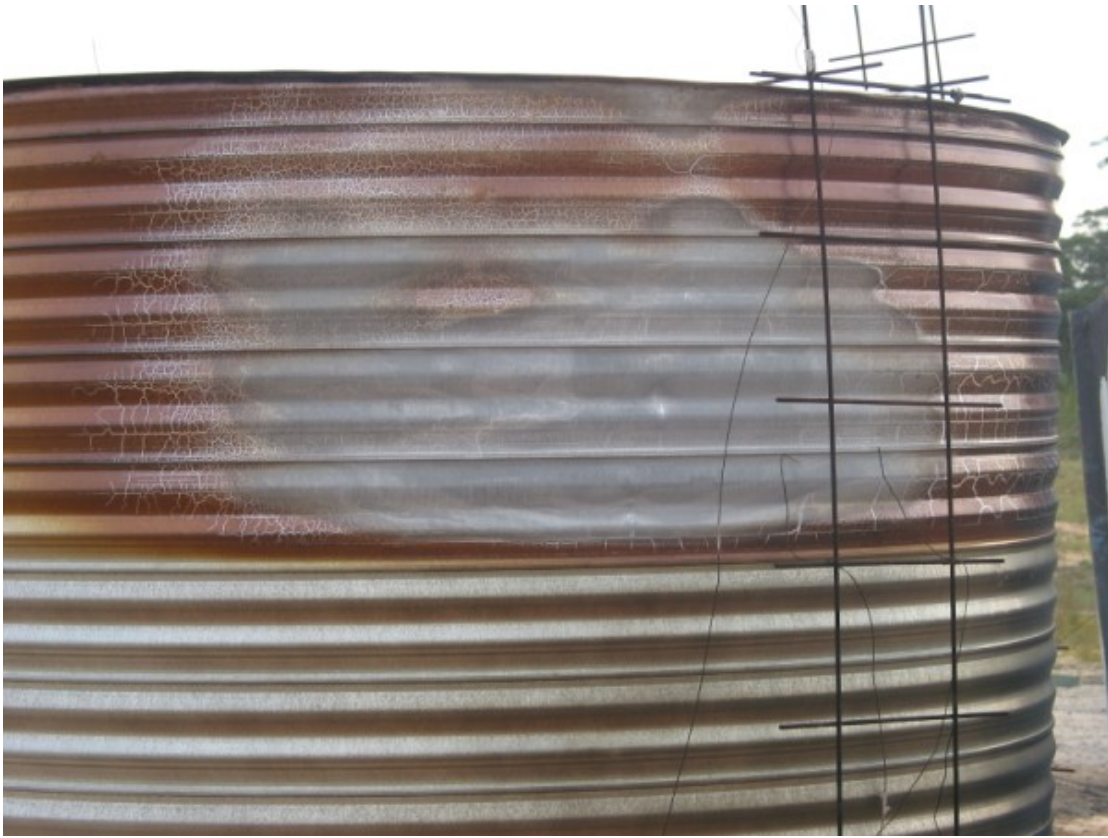
Figure C26 Tank five server damage resulting from structural exposure.

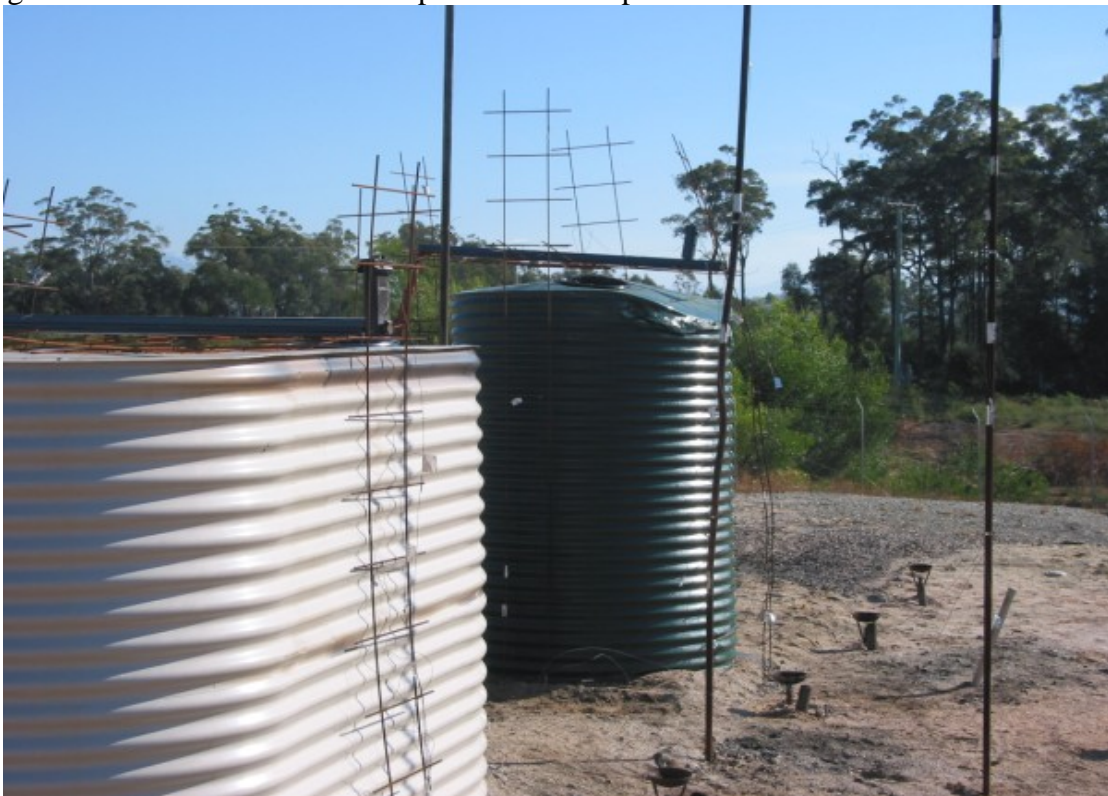
Figure C28 Tank two and four slight external damage resulting from pre-radiation exposure.

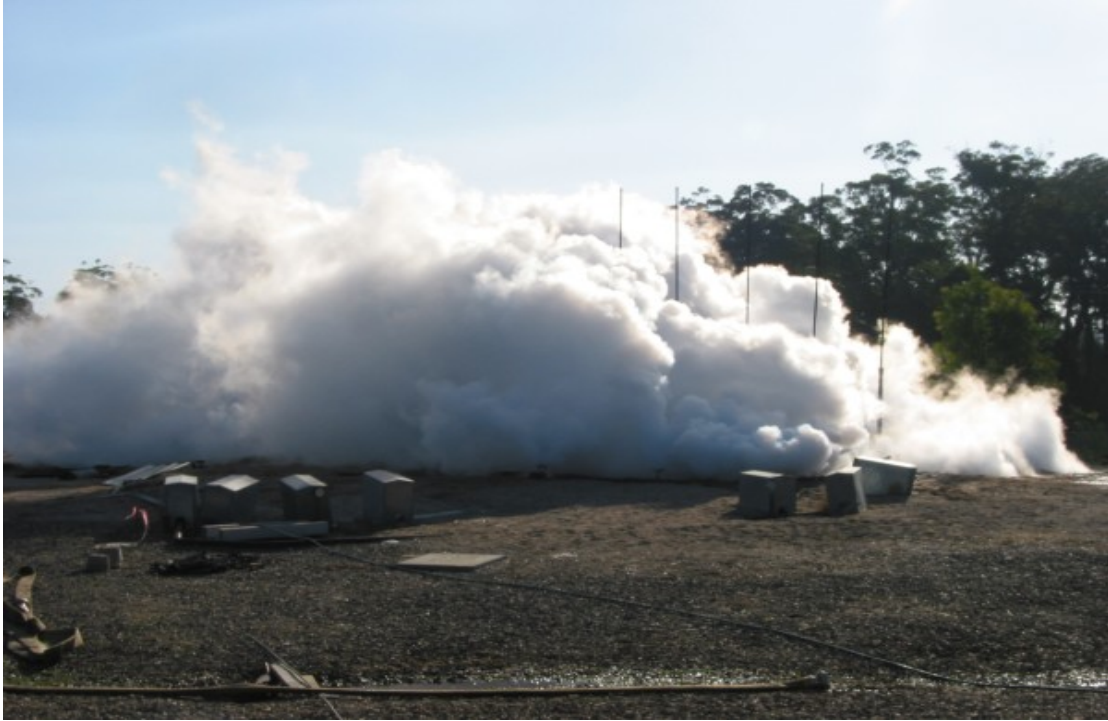
Figure C31 Tank four complete failure due to structural exposure. Escaping water extinguished gas burners.

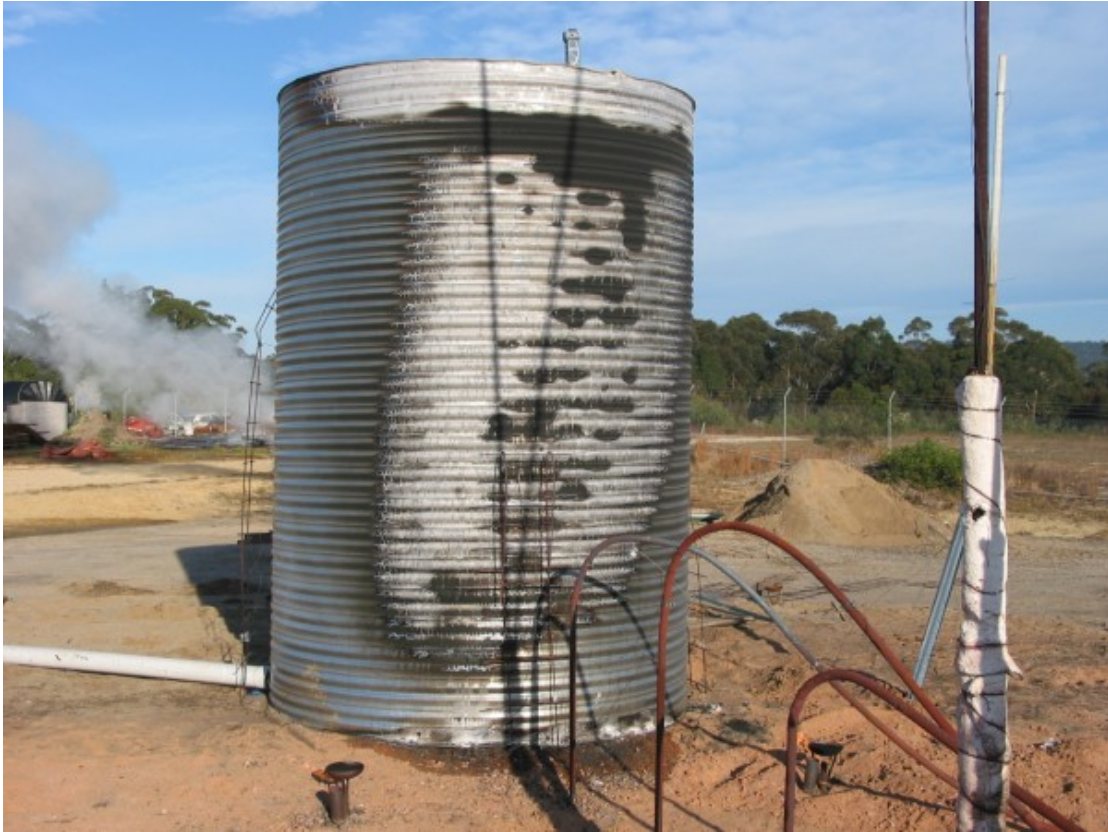
Figure C38 Tank 7 severe external damage resulting from structural exposure.

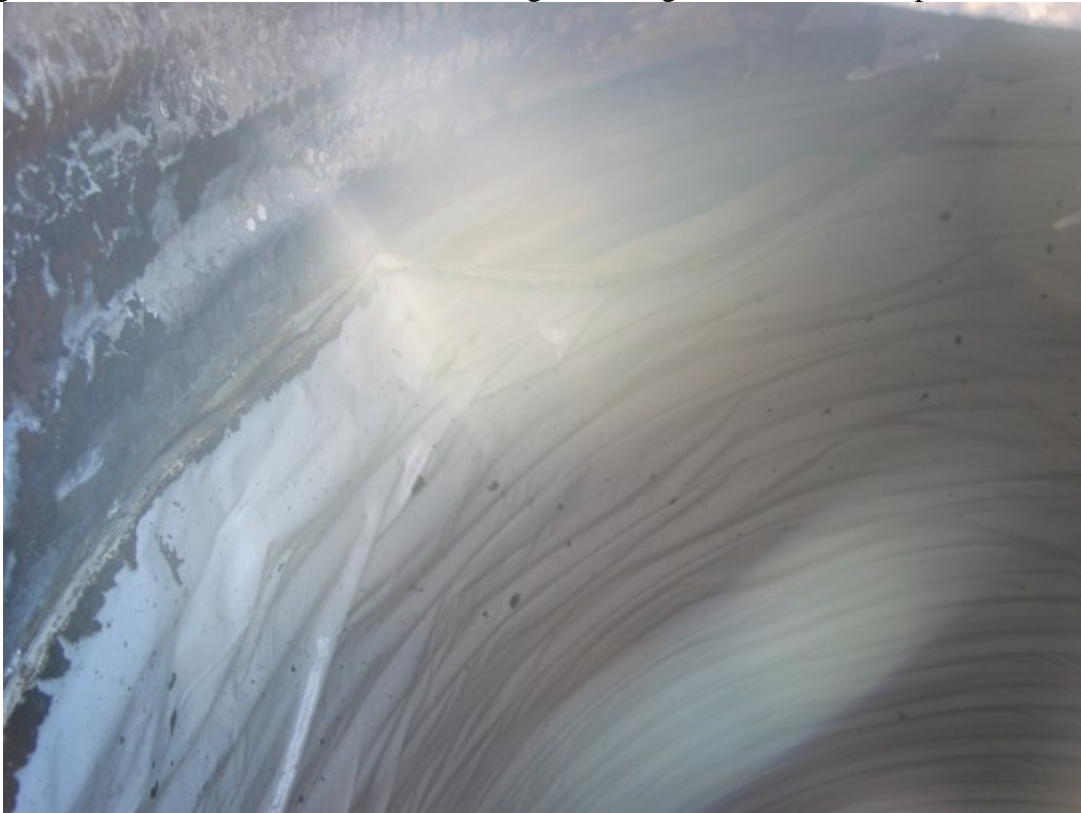
Figure C39 Tank 7 severe internal damage resulting from structural exposure.

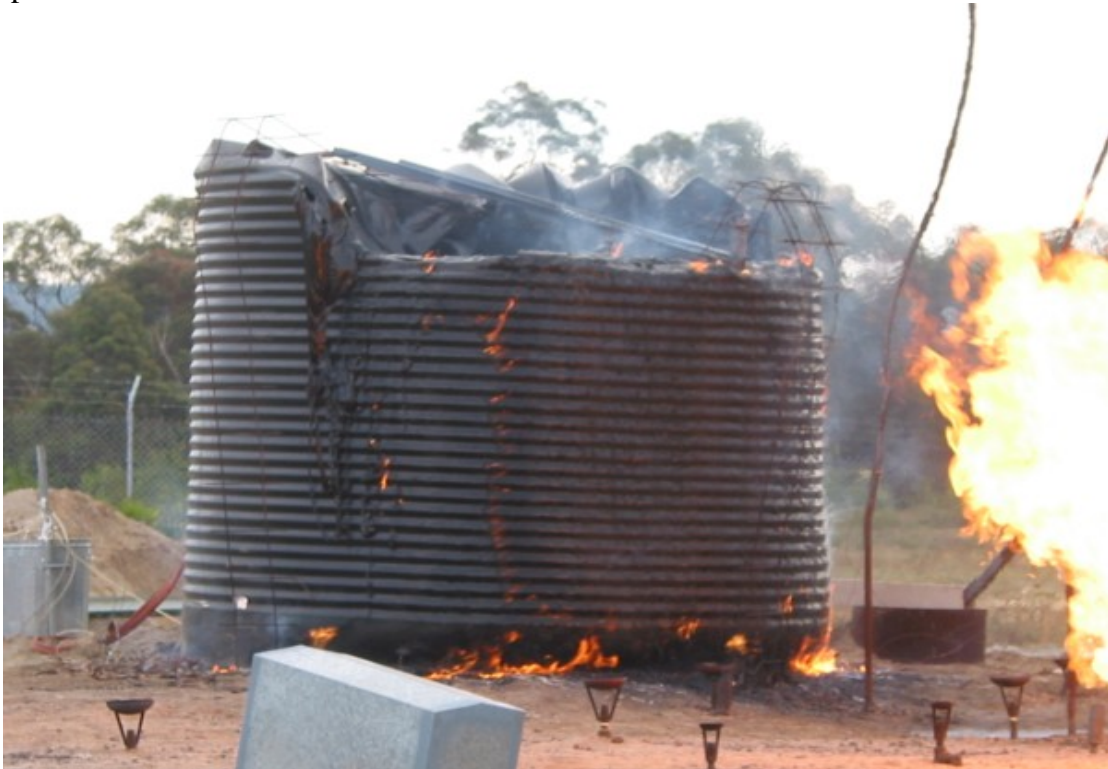
Figure C50 Tank 8 ignition and failure above waterline as a result of litter ignition and pre-radiation and flame exposure.
