**RESEARCH INTO THE PERFORMANCE OF  
WATER TANKS IN BUSHFIRE  
-Bushfire CRC Project D1**

**R. Blanchi, J.E. Leonard, N. White, A. Sargeant, A. Bicknell, S Andersson  
CSIRO – Sustainable Ecosystems (CSE)  
Urban Systems Program**

USP2007/014

December 2007

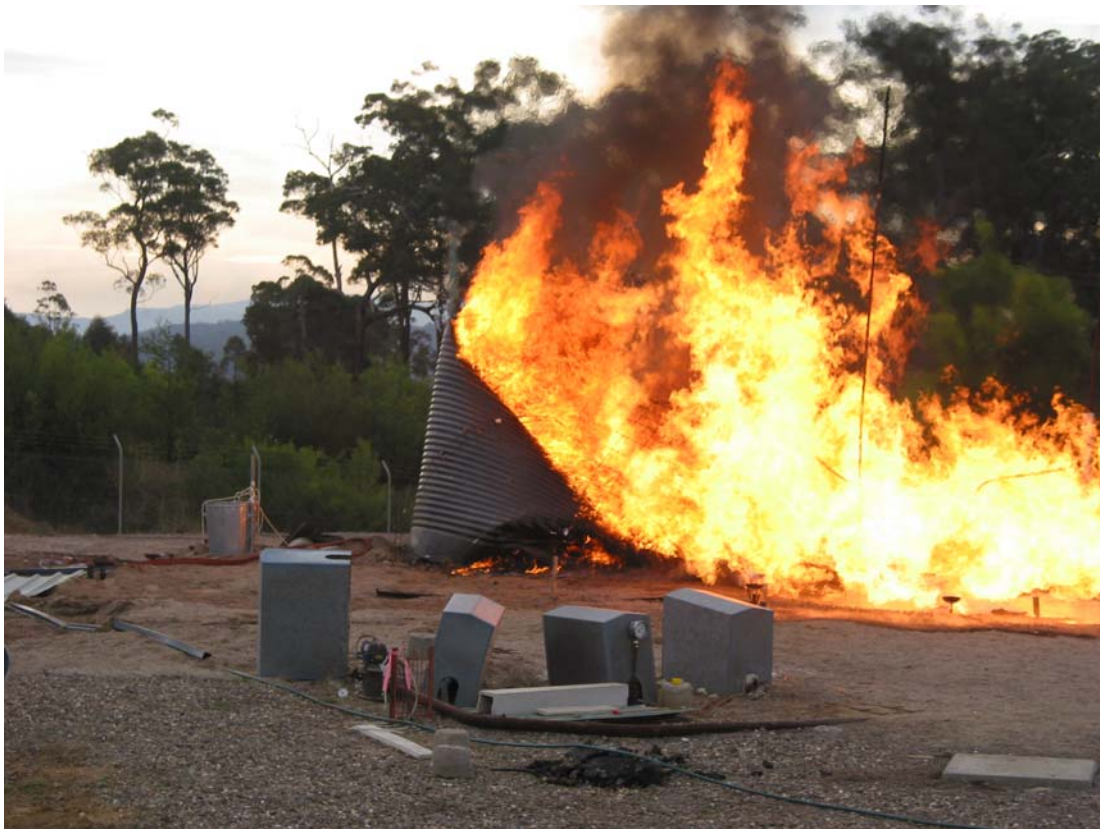
Figure C53 Tank 8 ignition and initial stages of failure due to structural fire exposure.

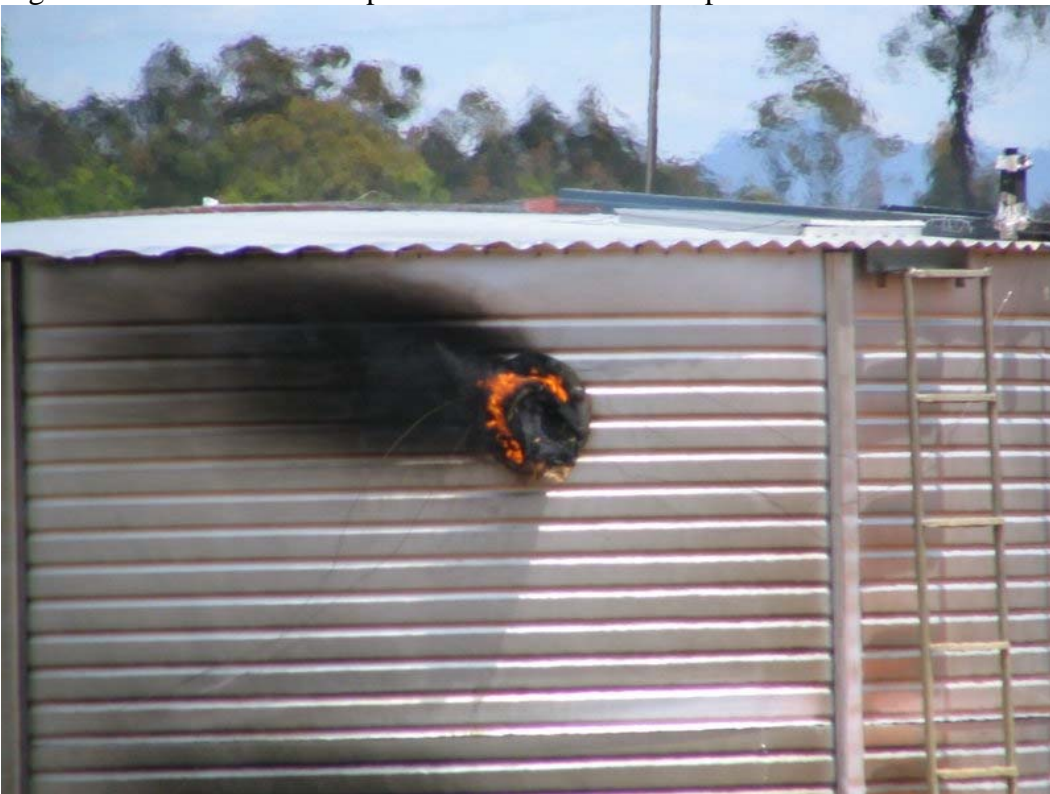
Figure C61 Damage to bladder tank overflow during pre-radiation and flame exposure.

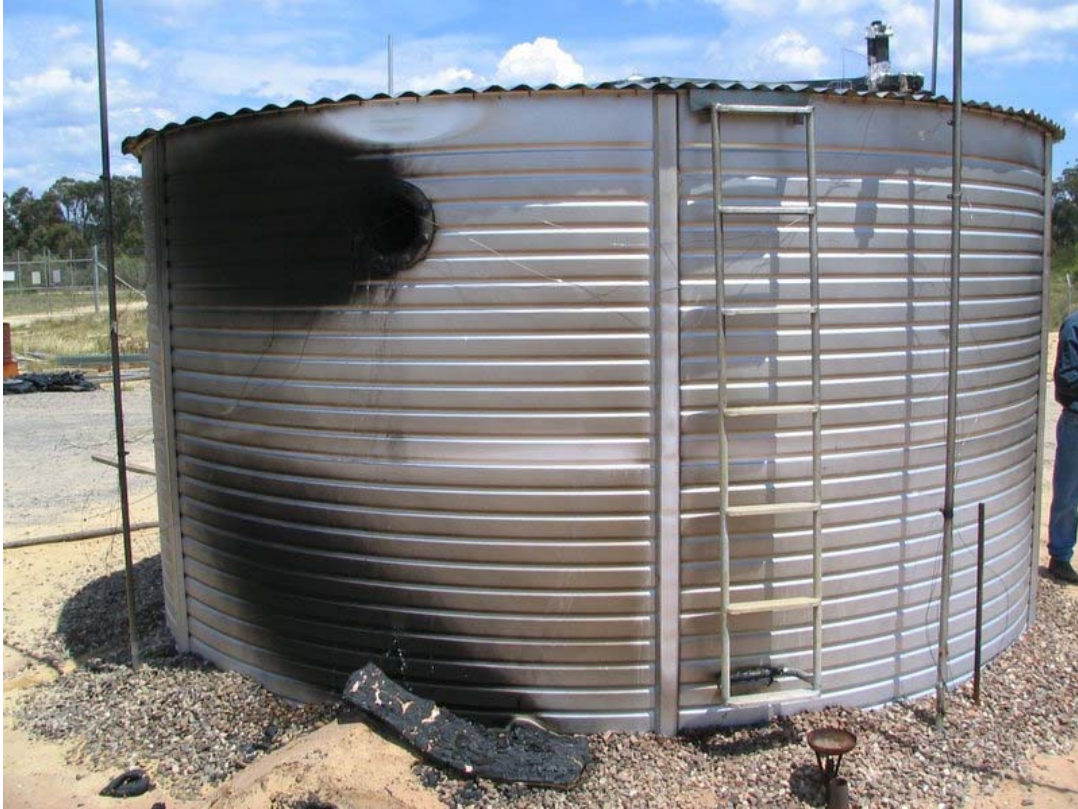
Figure C62 Damage to bladder tank overflow resulting from pre-radiation and flame exposure.

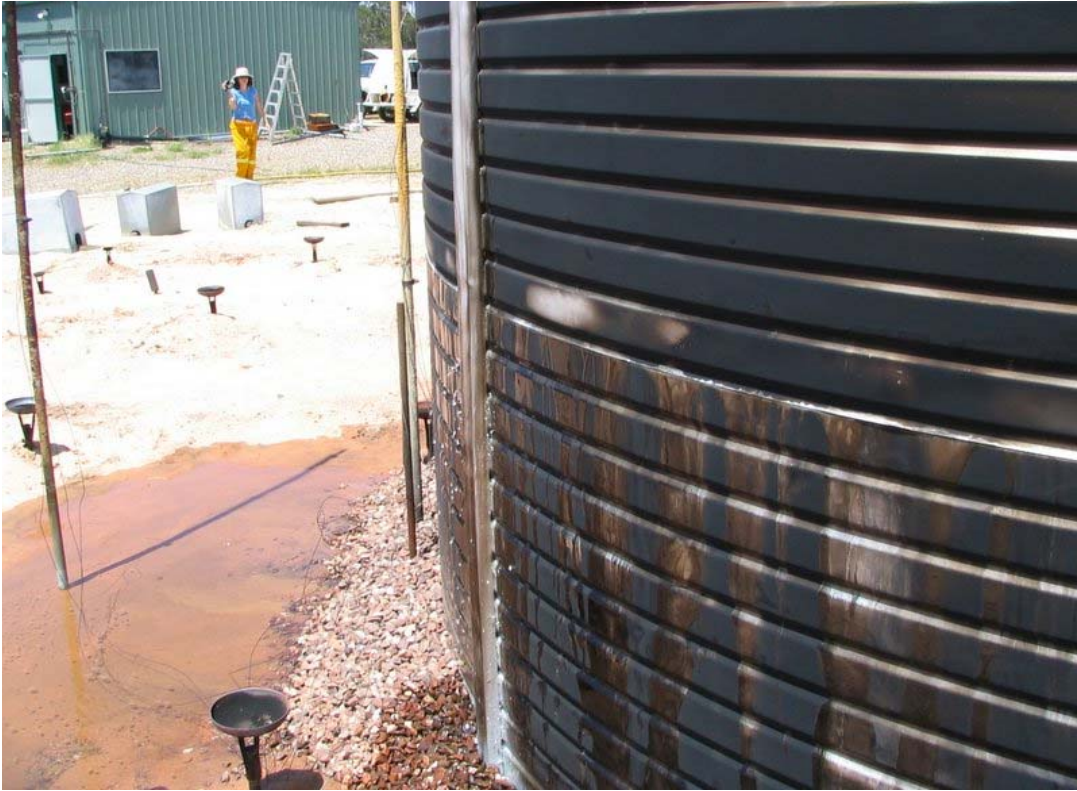
Figure C66 Bladder tank leaking and join damage as a result of structural exposure.

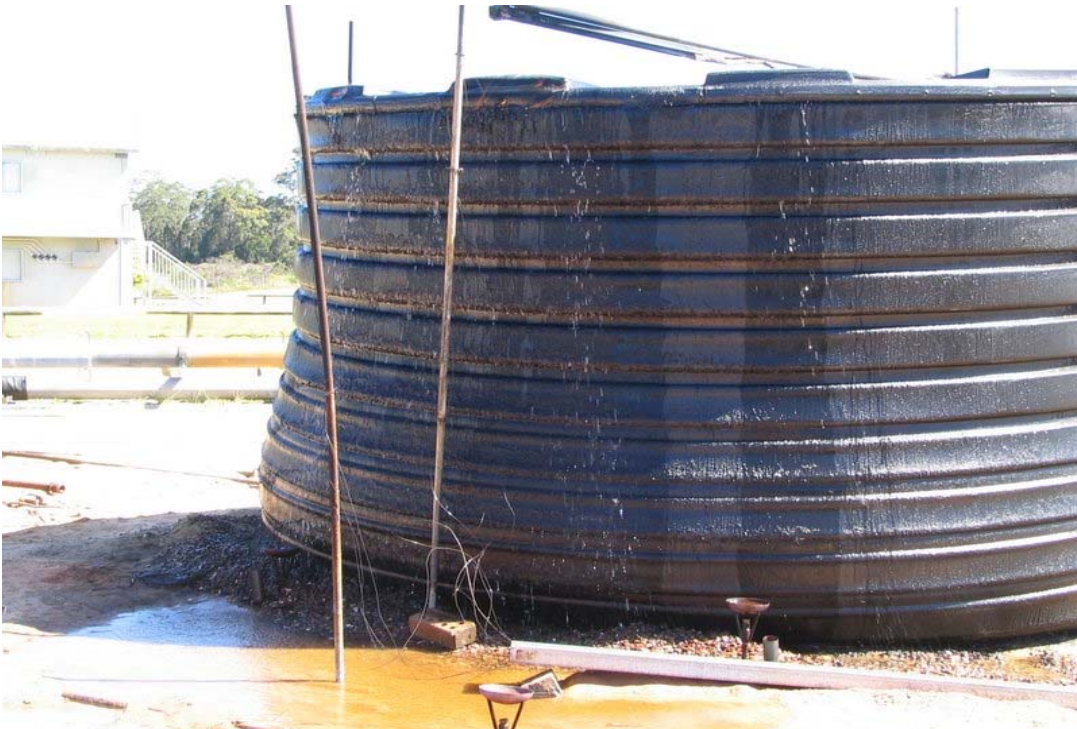
Figure C71 Tank 10 leaking as a result of litter ignition and pre-radiation exposure.

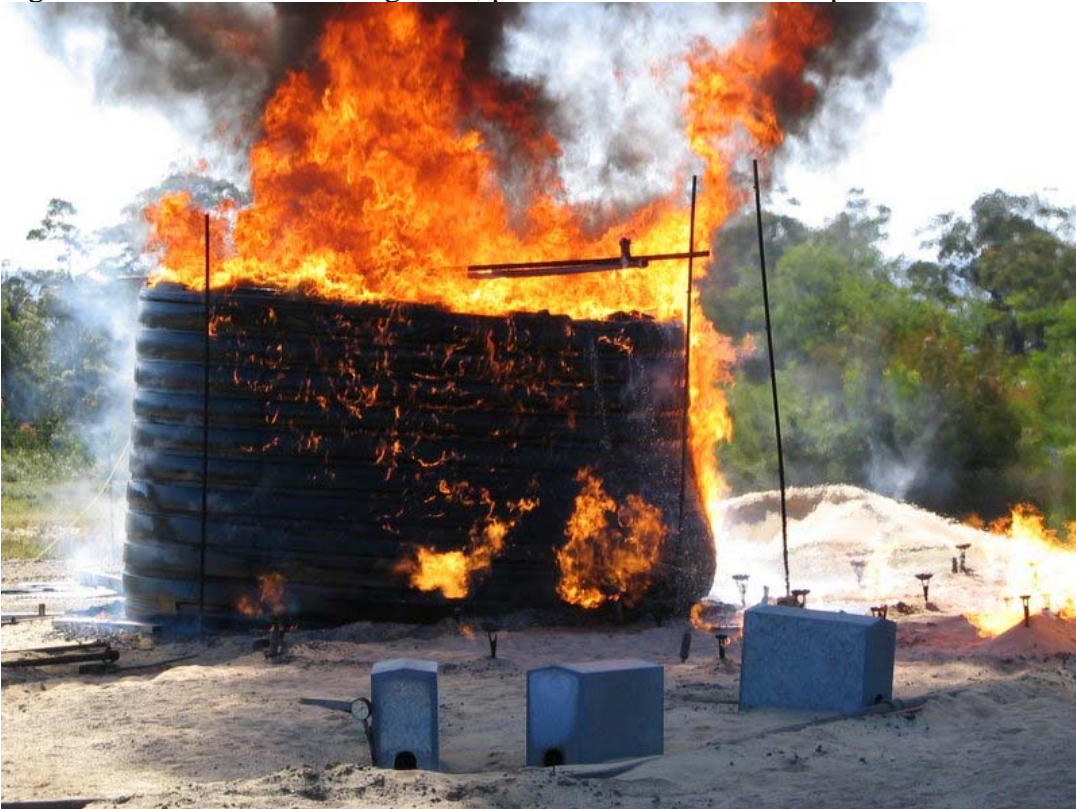
Figure C73 Tank 10 completely alight and about to fail as a result of litter ignition, pre-radiation and flame exposure.
