**RESEARCH INTO THE PERFORMANCE OF  
WATER TANKS IN BUSHFIRE  
-Bushfire CRC Project D1**

**R. Blanchi, J.E. Leonard, N. White, A. Sargeant, A. Bicknell, S Andersson  
CSIRO – Sustainable Ecosystems (CSE)  
Urban Systems Program**

USP2007/014

December 2007

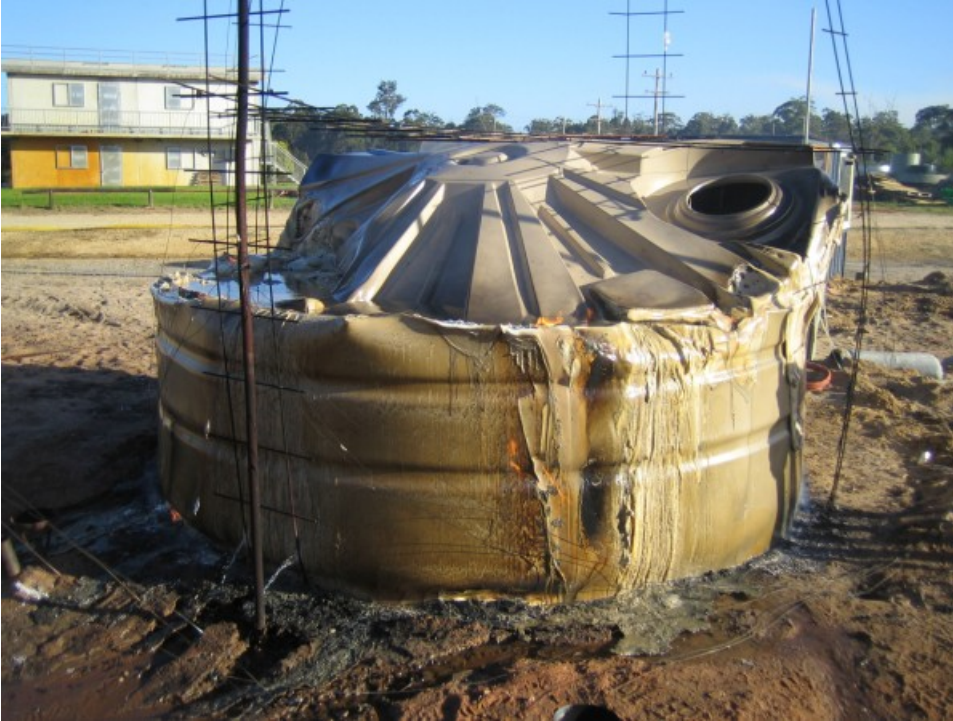
Smouldering on the front face of the tank is observed during early stage of radiation exposure. The bottom front began flaming after 7:00 and by 7:30 the entire front surface of the tank was involved in flame (see Figure 10). Flaming decreased at about 8:00 and ceased as burners are turned off. Temperatures of approximately 150°C were measured at the front exterior surface both above and below the water level just prior to flaming at these points. The experiment concluded with the top of the tank melted and deformed to the level of water, small flame still persisting on the top of the tank. There was water leaking out of the base of the tank at approximately 3 litres per minute, these leaks occurred at points where the tank had softened and expanded around its base by approximately 150 mm and contacted the instrument support rigging. Figure 11 below shows this extent of damage and leaking.

**Figure 11 Experiment 5 - Pre-radiation exposure on polyethylene tank (note water stream from the base of the tank)**

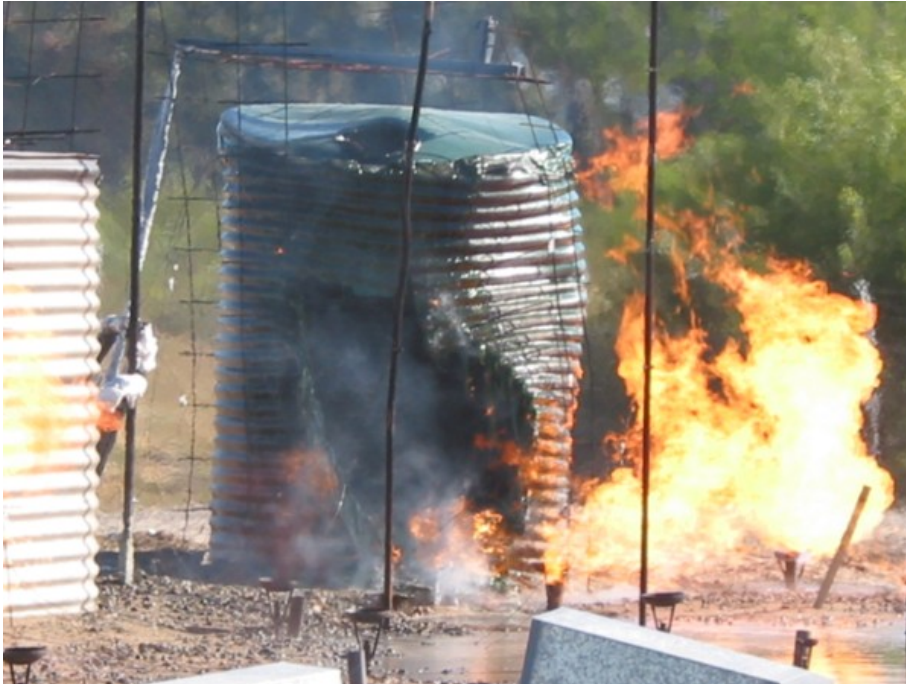
During the structural fire exposure further scorches and leakage from seams appeared on the metal tank, leakage was considered to be less than 0.3 litres per minute. Tank 4 failed when a small hole rapidly propagated releasing all water (unzipped) at 2 minutes after the start of the test (see Figure 21). The tank then collapse on itself (see Figure 22). The test was terminated shortly after tank 4 ruptured.

**Figure 21 Experiment 14 - Structure exposure on polyethylene and metal tank**

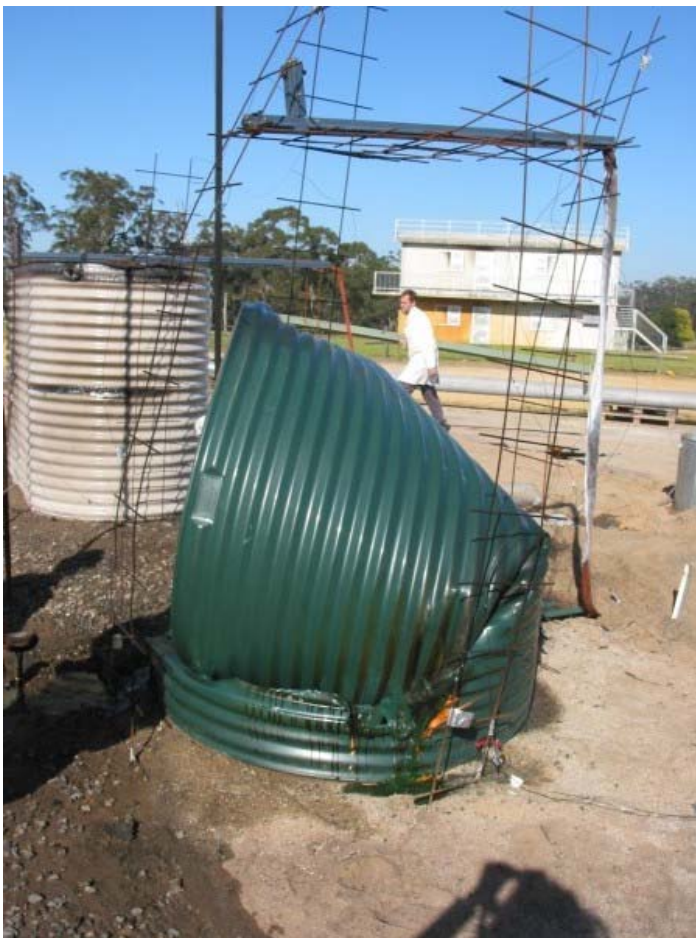
**Figure 22 Experiment 14 - Structure exposure on polyethylene and metal tank**

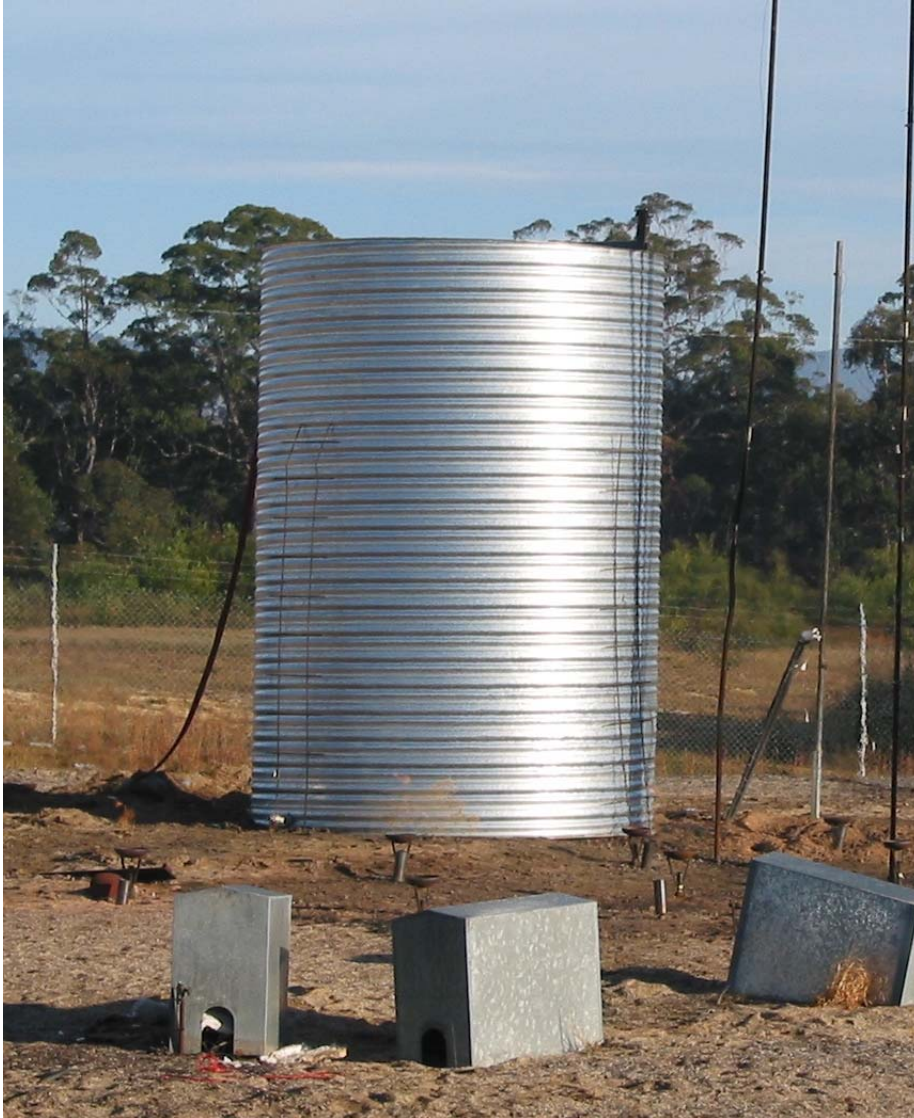
**Figure 24 Experiment 16 – Radiant heat flux – Tank 7 Spiral wound metal galvanised**  
 The front face of the tank was blackened with no apparent leaks or loss of integrity.

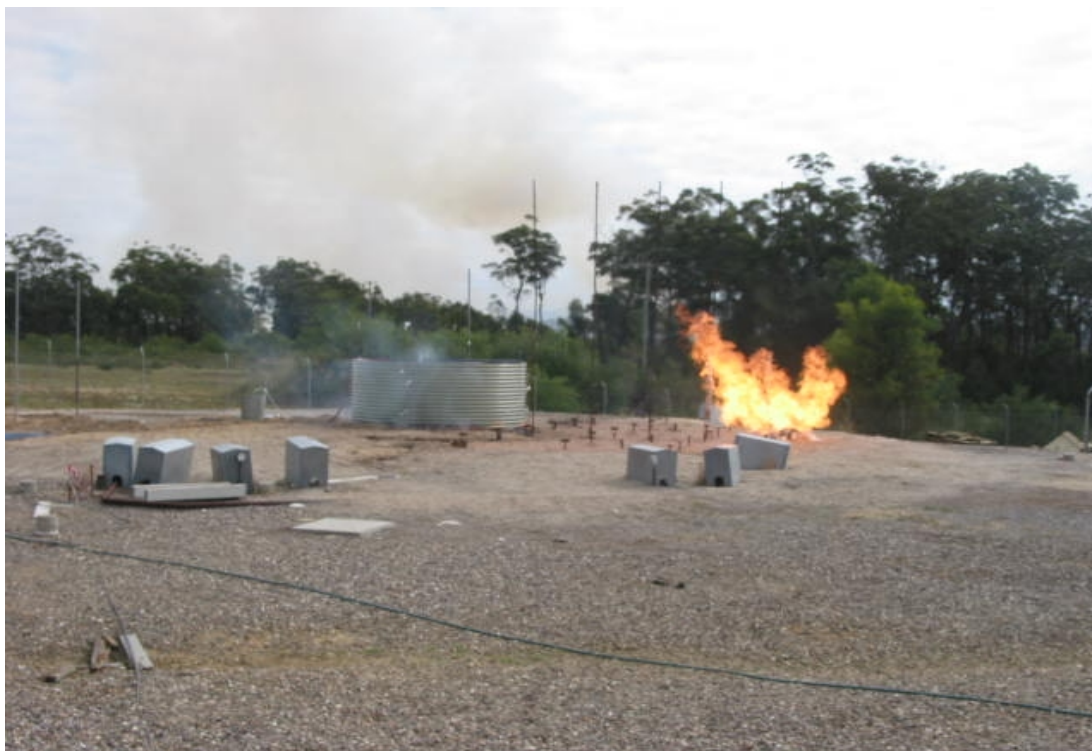
Figure C1 Tank one, metal tank with plastic coating, Pre Radiation exposure.

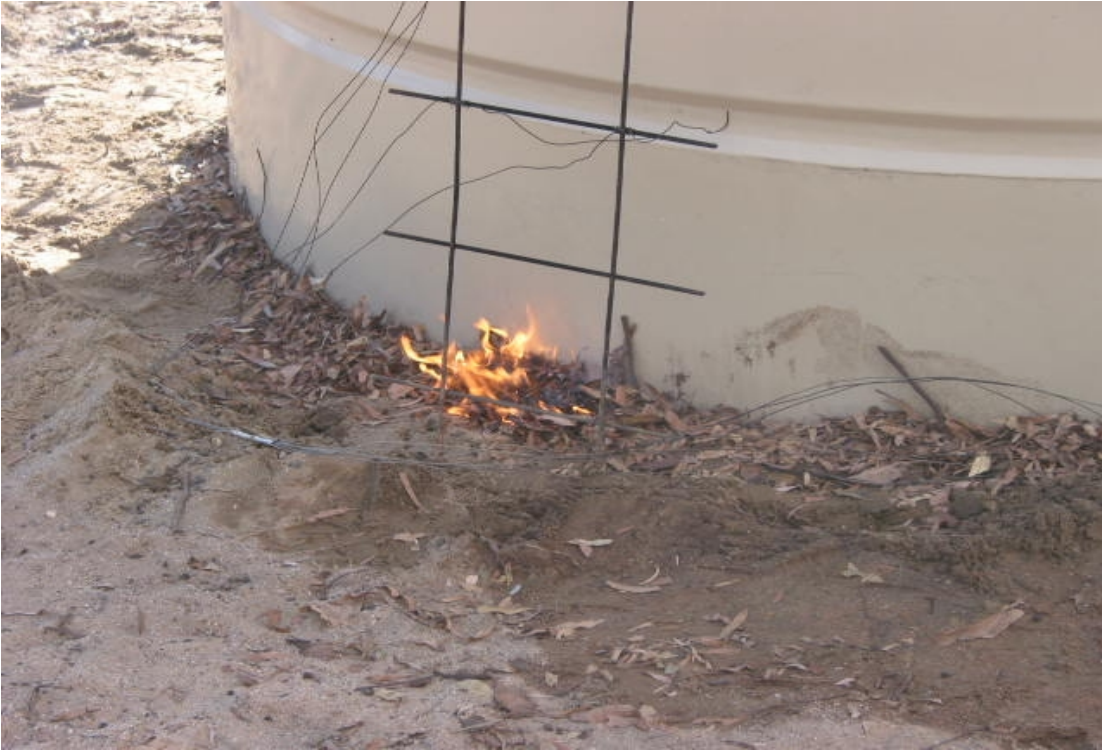
Figure C7 Tank six Litter ignition.

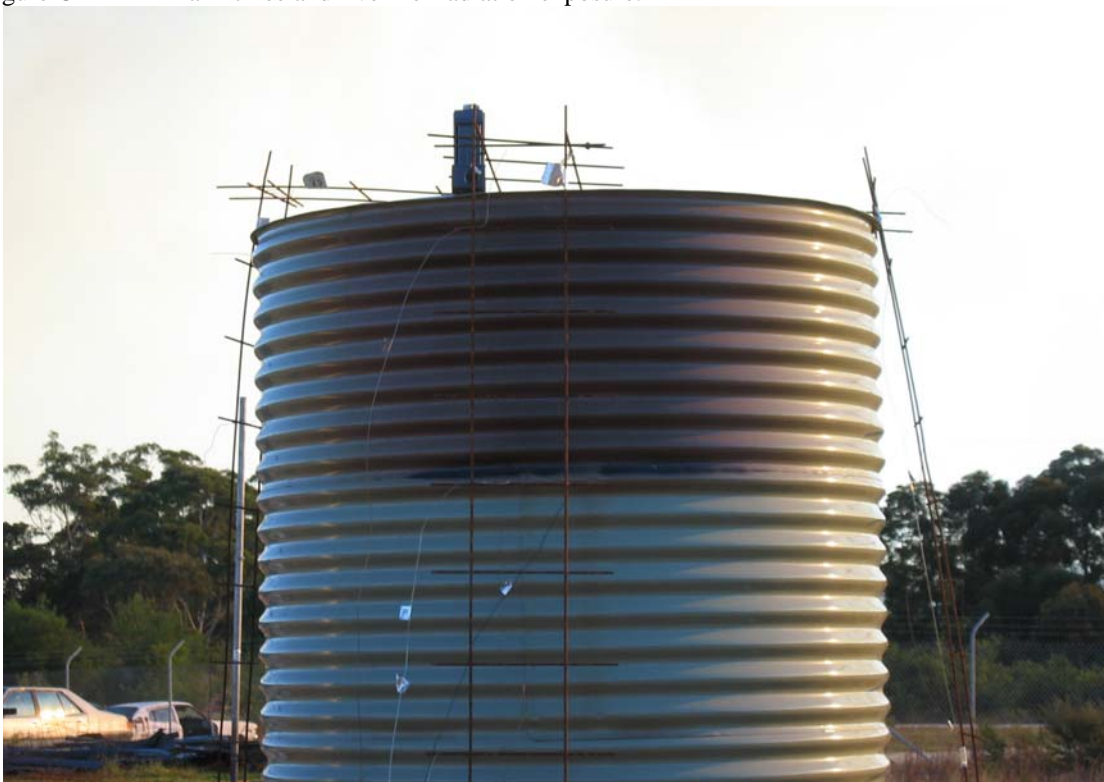
Figure C15 Tank three scorch mark above the water line.

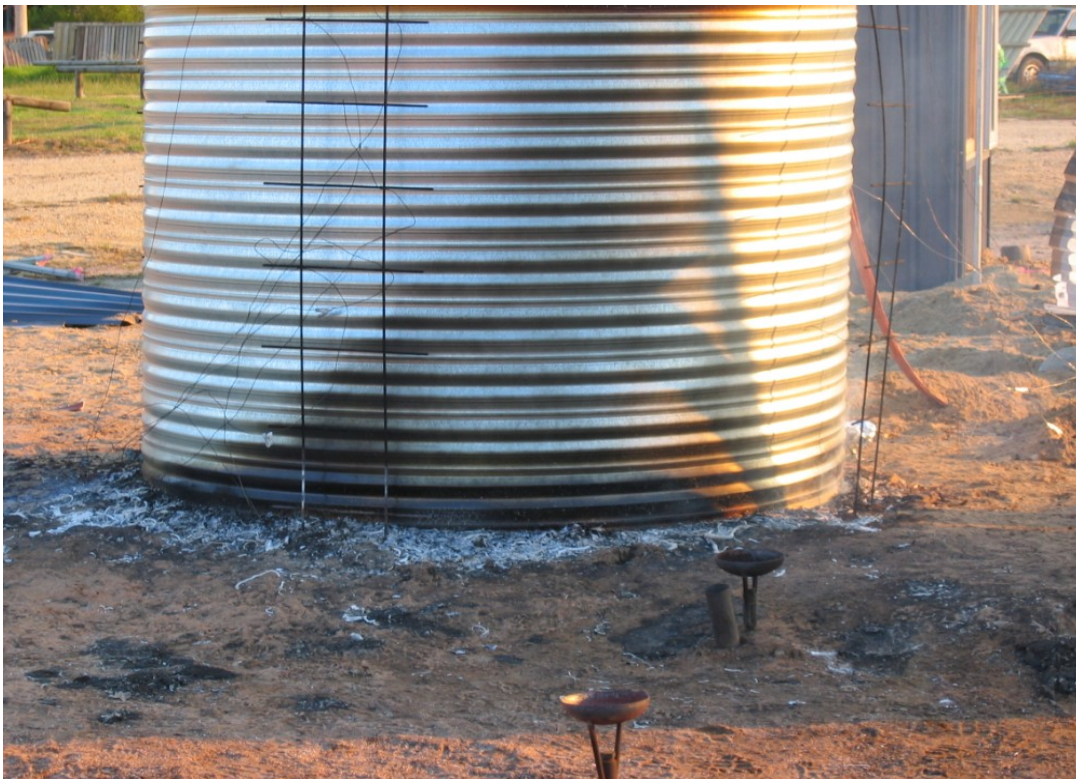
Figure C17 Tank five minor scorching from litter ignition.

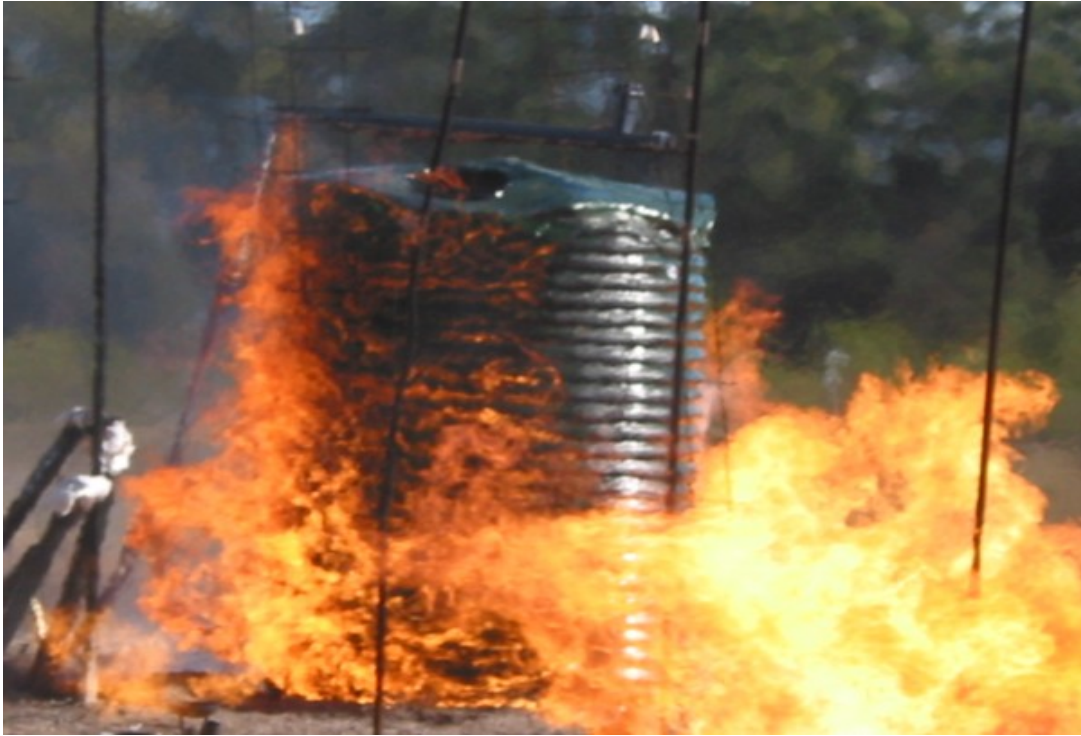
Figure C28 Tank four flame exposure.

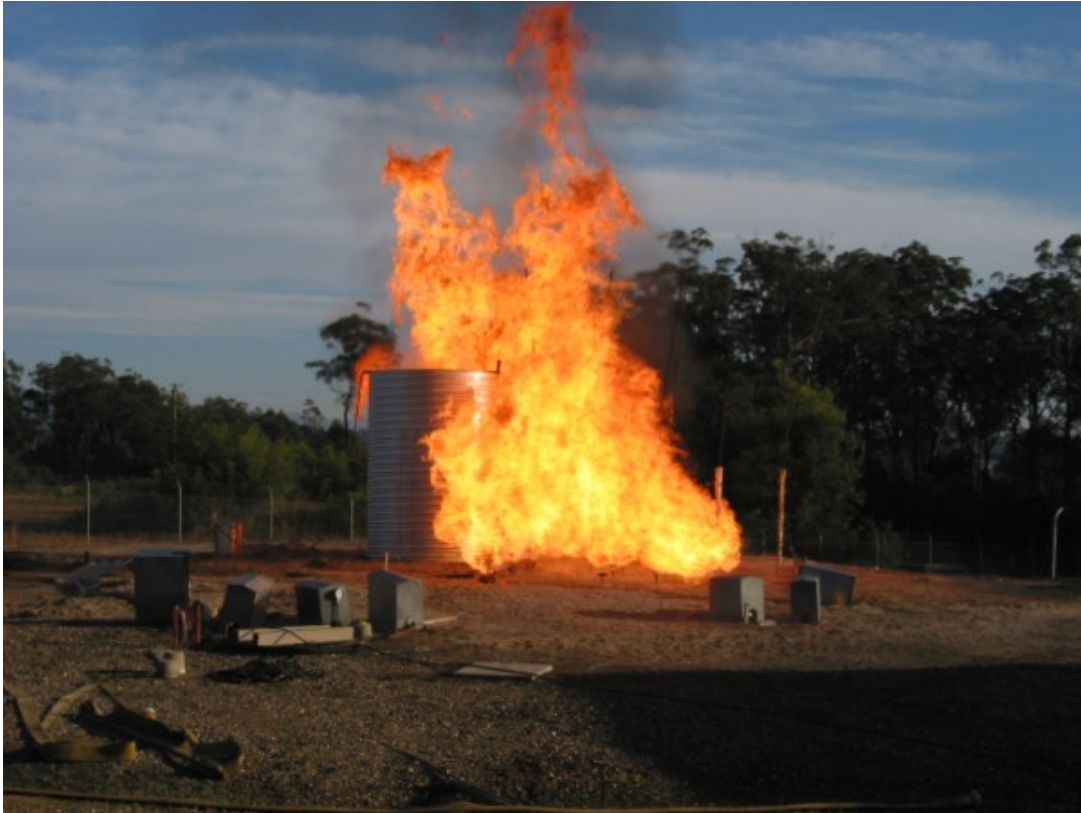
Figure C36 Tank 7 structural exposure.

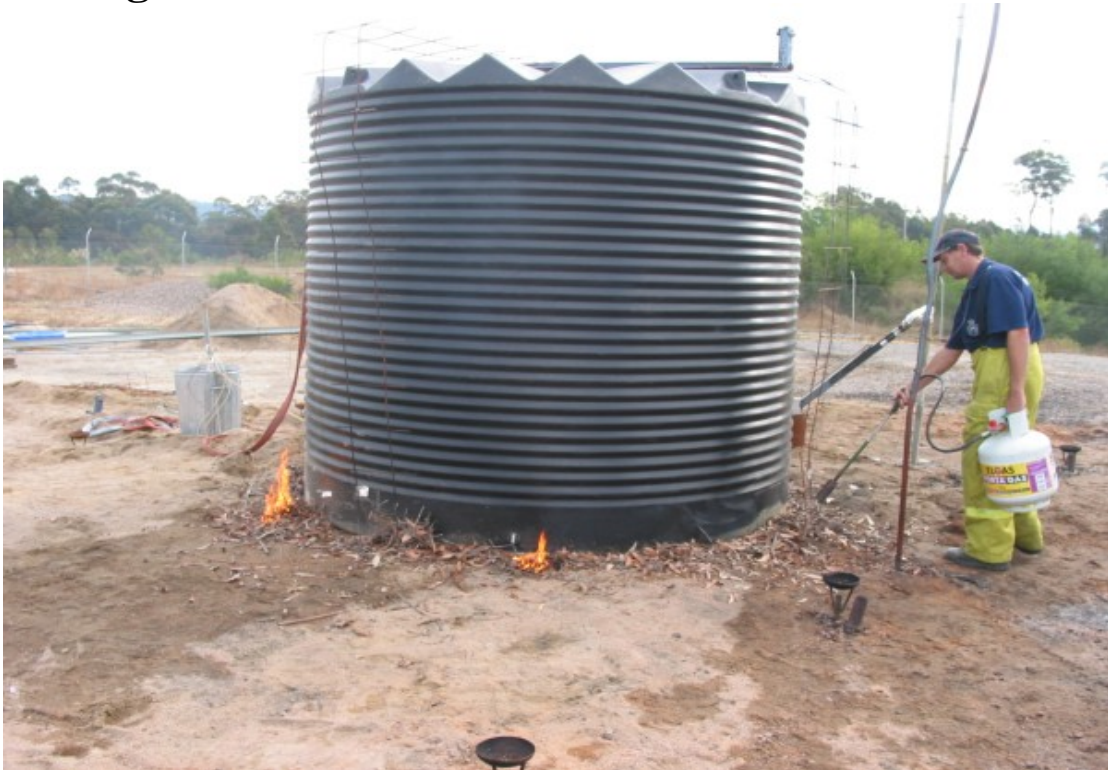
Figure C41 Tank 8 litter ignition .

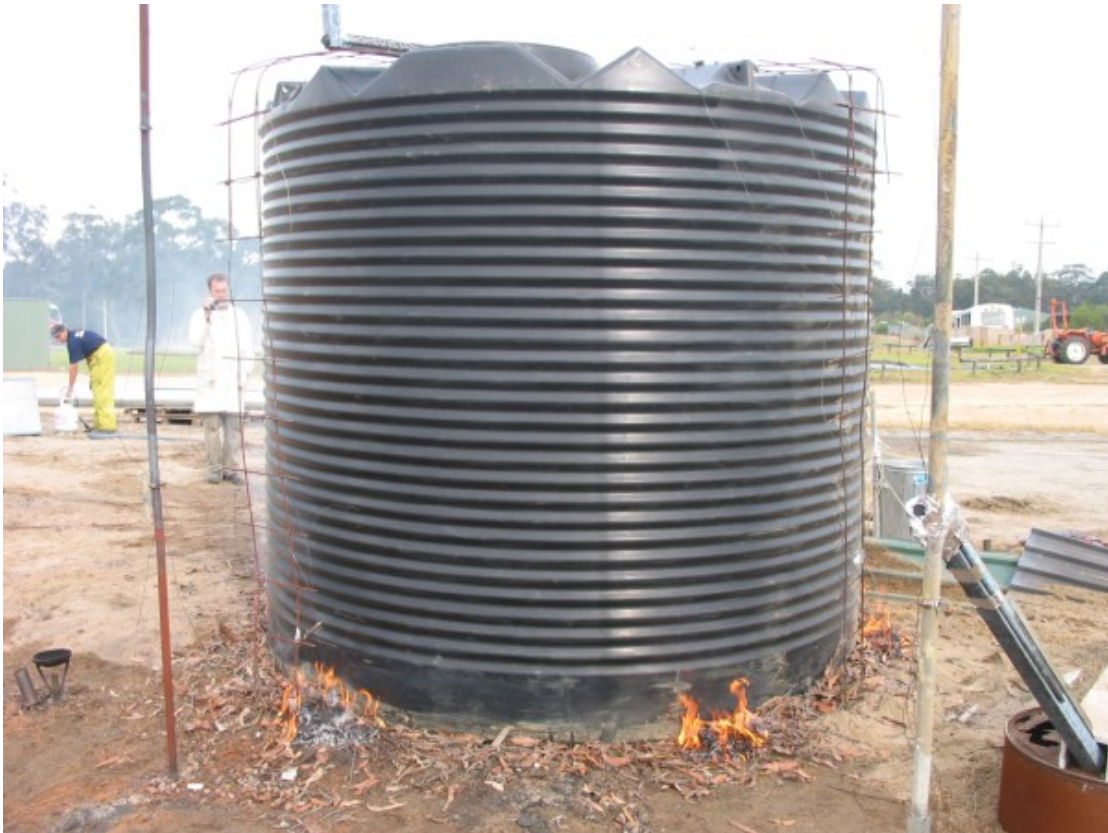
Figure C42 Tank 8 litter ignition .

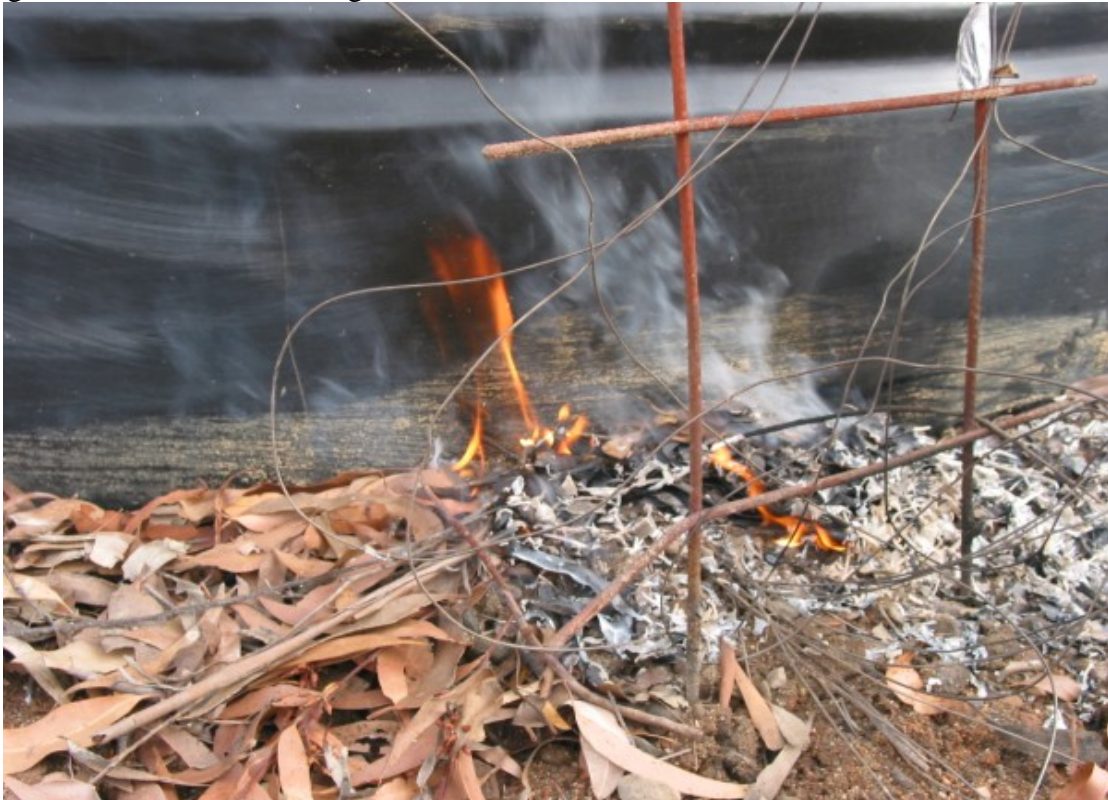
Figure C41 Tank 8 litter ignition .

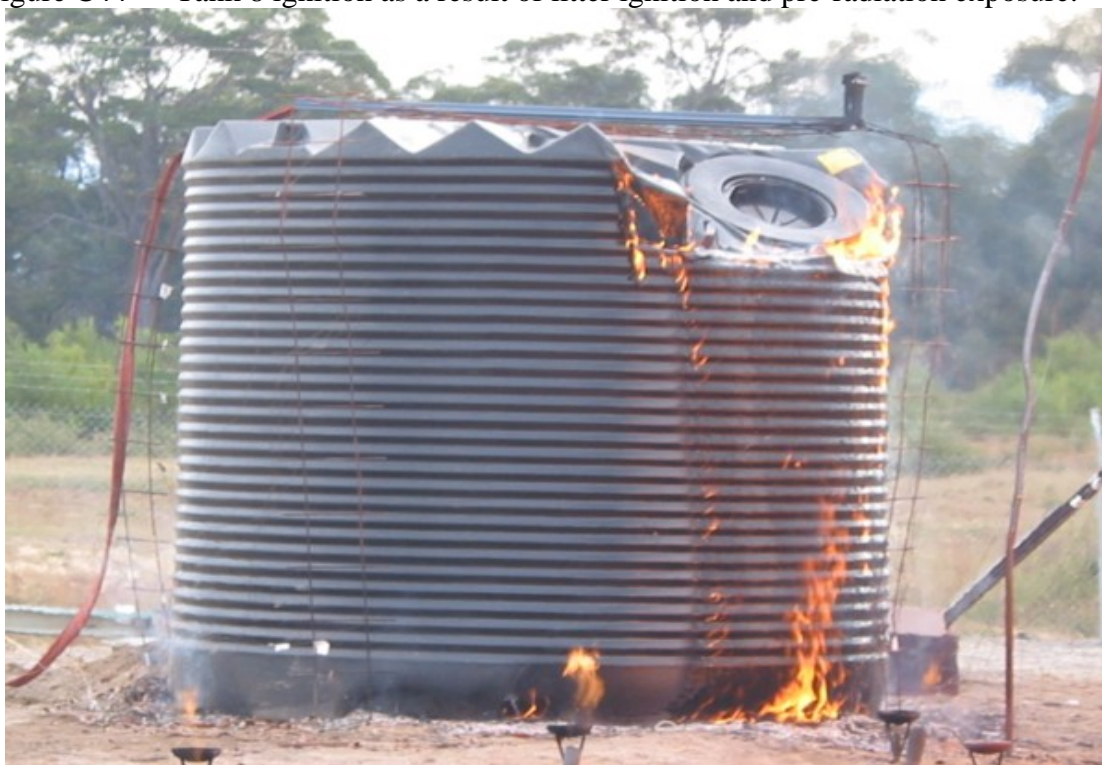
Figure C45 Tank 8 ignition as a result of litter ignition and pre-radiation exposure. Flowing water from the collapsing upper portion of the tank assisting extinguishing flames.

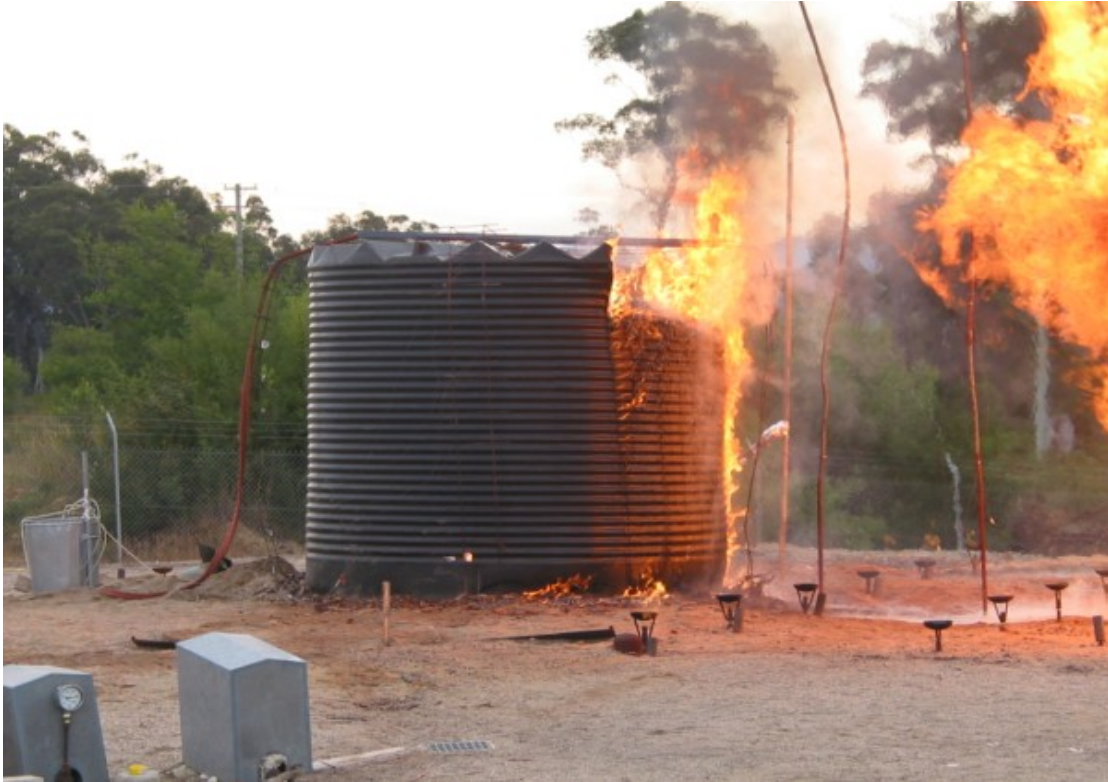
Figure C47 Tank 8 ignition as a result of litter ignition and pre-radiation and flame exposure.

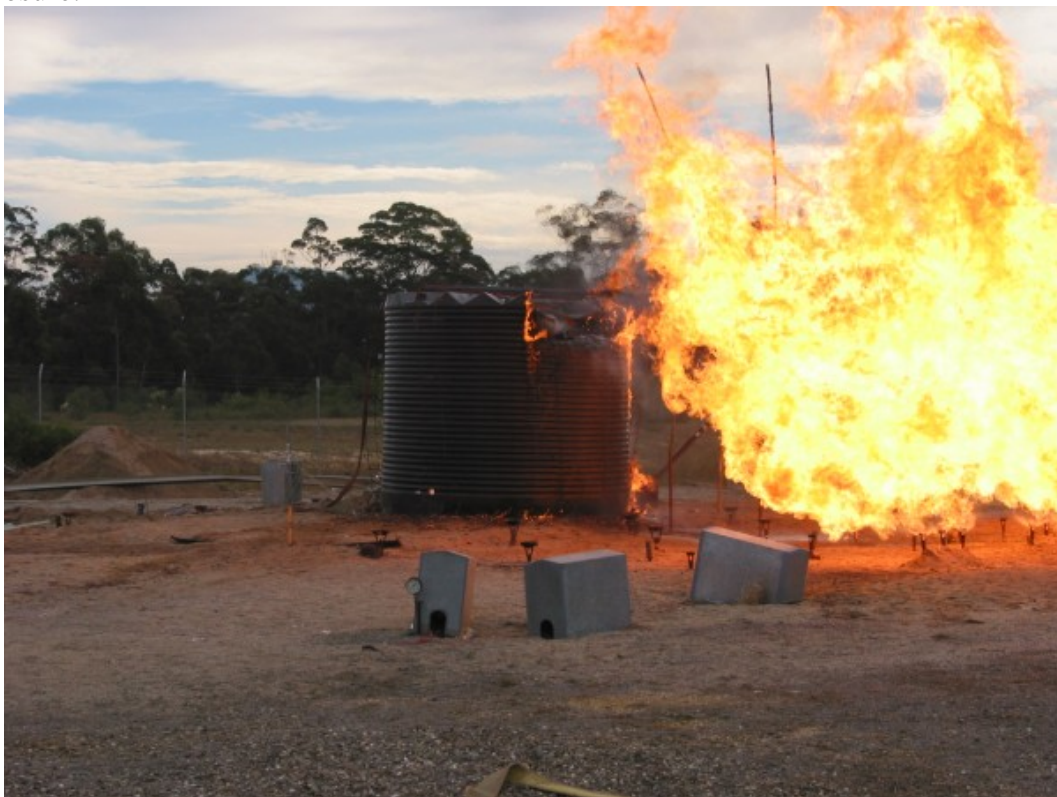
Figure C48 Tank 8 ignition as a result of litter ignition and pre-radiation and flame exposure.

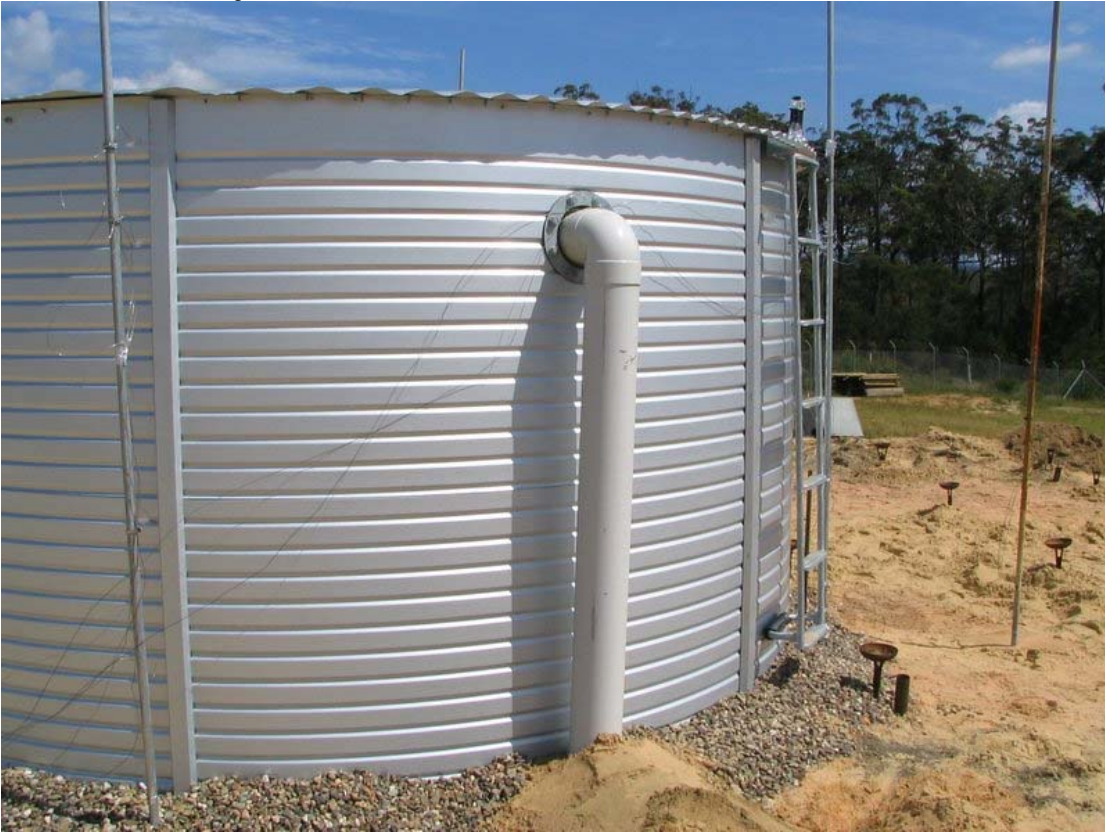
Figure C55 Tank 9, bladder tank.

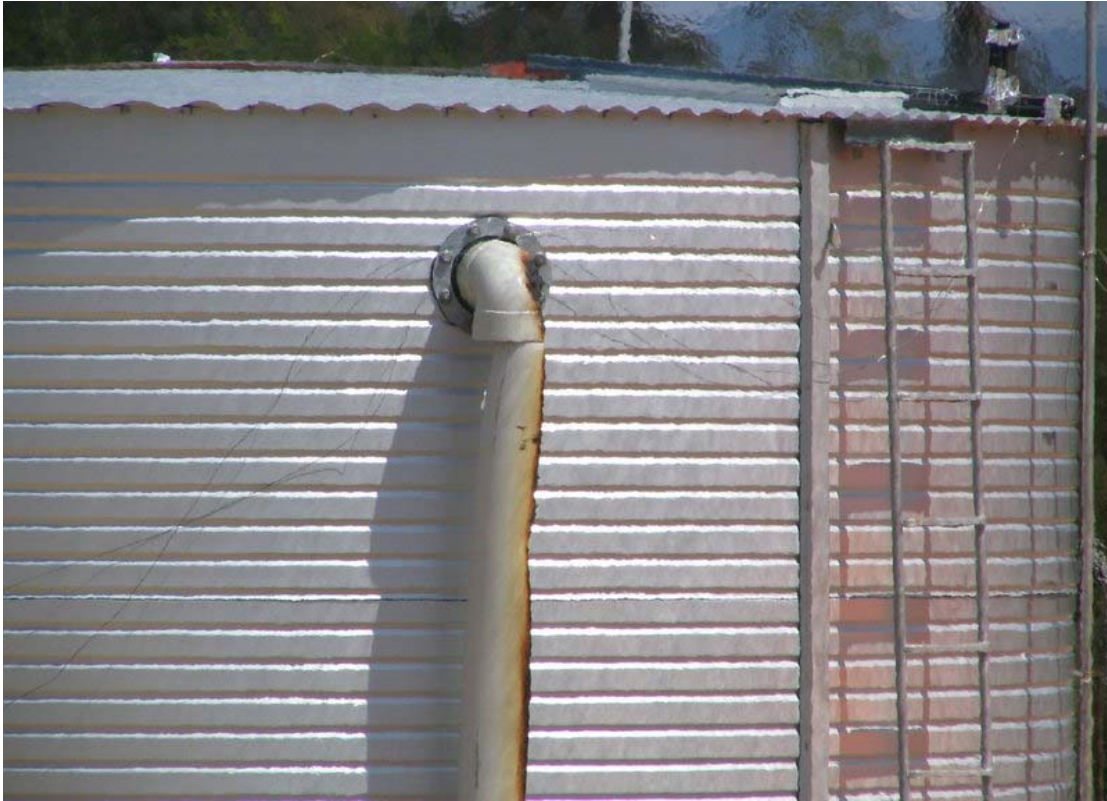
Figure C58 Bladder tank overflow charring during pre-radiation exposure.
