**RESEARCH INTO THE PERFORMANCE OF  
WATER TANKS IN BUSHFIRE  
-Bushfire CRC Project D1**

**R. Blanchi, J.E. Leonard, N. White, A. Sargeant, A. Bicknell, S Andersson  
CSIRO – Sustainable Ecosystems (CSE)  
Urban Systems Program**

USP2007/014

December 2007

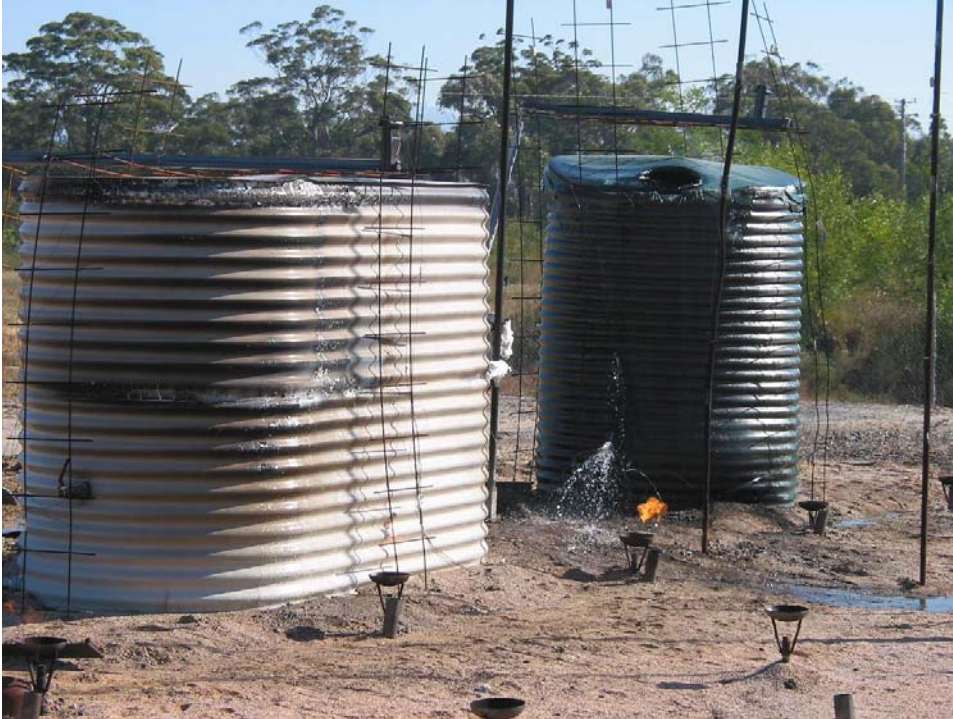
8 minutes after the beginning of the test the front surface of tank 4 become involved in flame. After 9 minutes and 5 seconds the plastic tank started to leak water from a hole on the South-East side, 0.5 meters up ( $\frac{1}{4}$  of the bottom of the tank) (see Figure 20). This leak is estimate to be 5 litres per minute.

**Figure 20 Experiment 13 - pre-radiation and flame exposure**

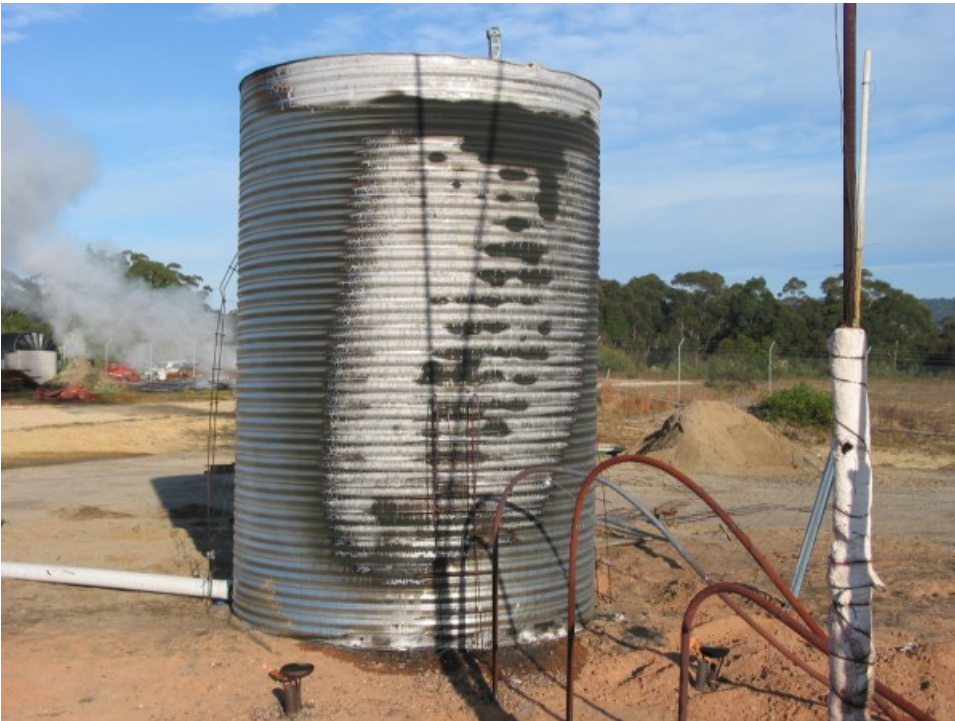
The front face of the tank was scorched, with minor leaks of approximately 0.3 litres per minute (see Figure 27). The liner inside the tank is melted and damaged above the water line with some de-lamination having occurring below the waterline also (see Figure 26).

**Figure 27 Experiment 17- Structure exposure on metal spiral tank**

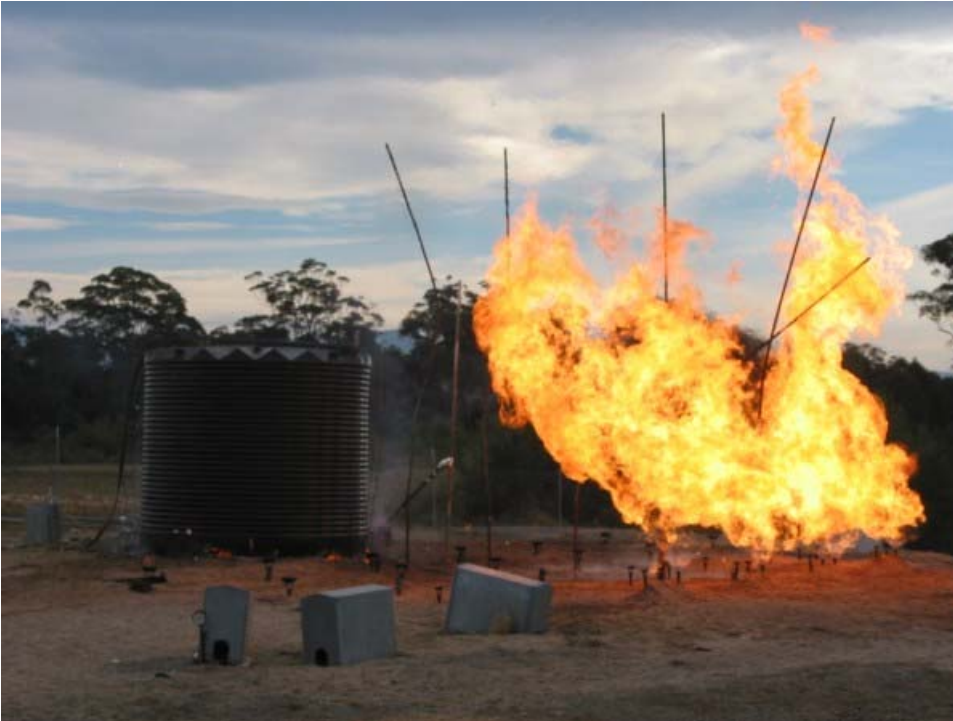
Small flames started from the bottom of the tank and then spread to involve the entire front of the tank by 7 minutes (see Figure 29 and 30). The flames on the front reduced to small flames around the top rim of the tank when the burners were reduced. The top of the tank above the water level melted in part and drooped to the waterline (see figure 31). There was no significant leakage of water.

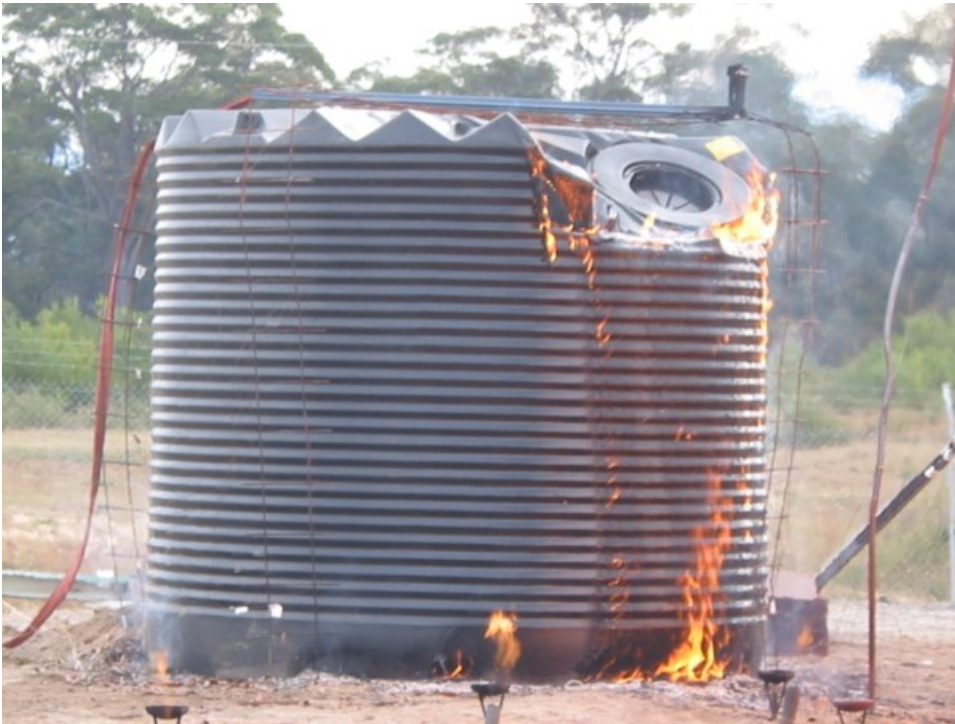
**Figure 31 Experiment 19 - pre-radiation exposure**

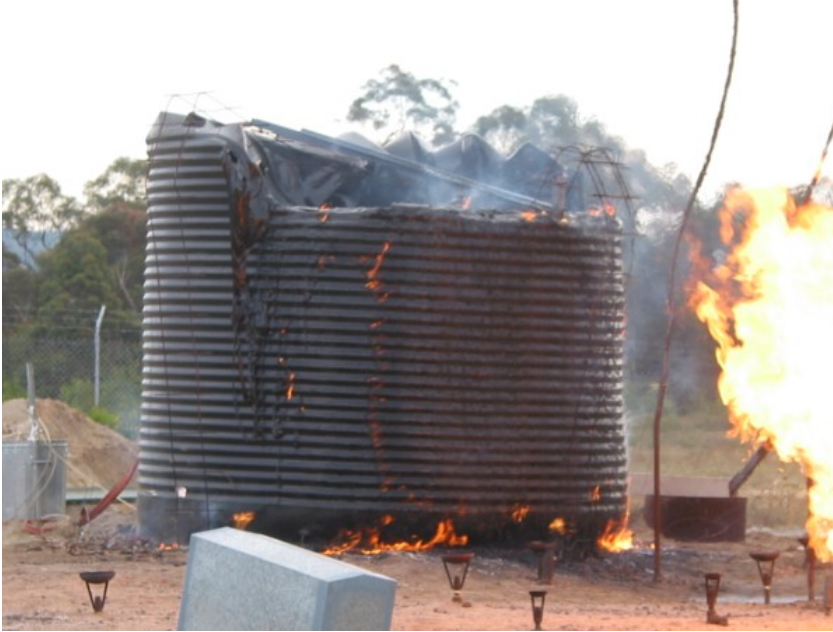
After the burners were shut off the flames reduced to small flames around the top edges of the tank. There was more melting of the top of the tank above the water level (see Figure 34) Water was flowing from around the melted rim of the tank extinguishing much of the surface combustion. The base of the tank had significant bulging and appeared to be close to structural failure.

**Figure 34 Experiment 20 – Pre-radiation and flame exposure on polyethylene tank**

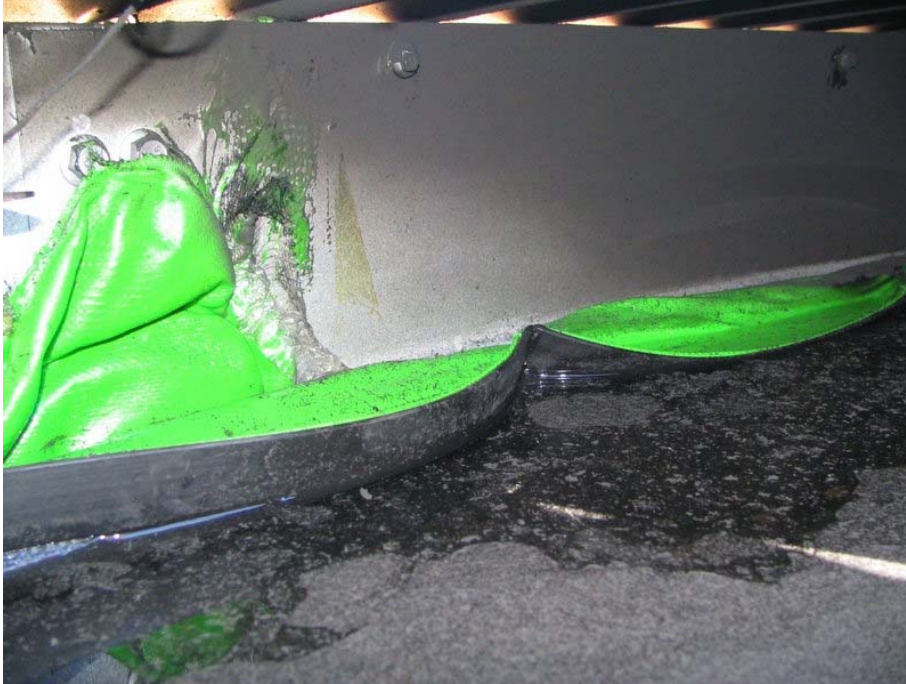
Leaks were observed from the top opening where the overflow pipe penetrated the tank. Leakage was observed at the horizontal metal joint between the top and bottom tank sheet metal sections at the mid height of the tank. The four vertical joints (front, sides and back) were also leaking. The attachment of the bladder to the tank (screwed around the inside top rim of the tank) had failed at the front of the tank where the exposure had been most intense. The bladder had melted and come away from some of the screw mounting points. Where the bladder attachment had failed the bladder had slumped down to the water surface allowing water to slowly flow over the top of the bladder. This water then flowed between the bladder and the sheet metal shell and leaked out from the joints mentioned above (see Figure 38). Water loss from the tank is estimated at 3 litres per minute. The external surface temperature at the front top rim of the tank, near the location of bladder attachment exceeded 500°C during the exposure.

Figure 38 Experiment 23 – pre-radiation exposure on Bladder tank

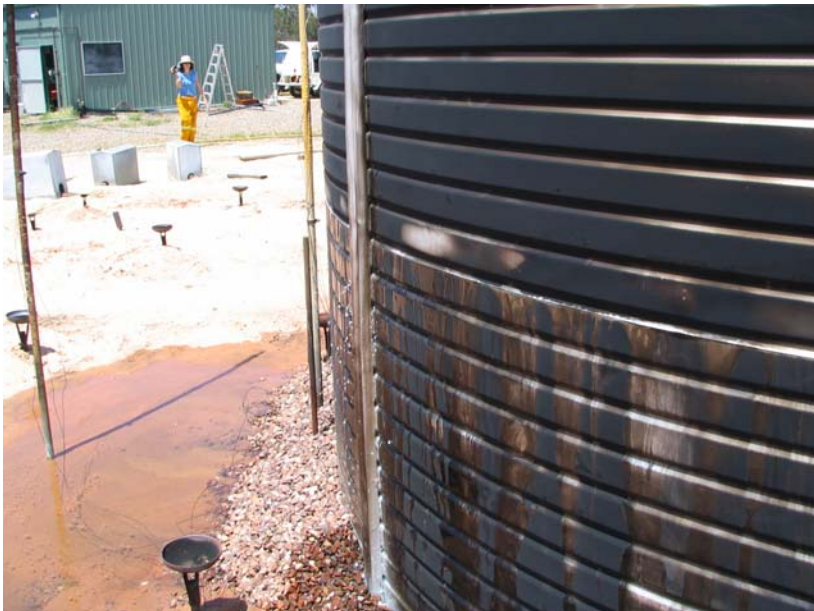
Structure exposure caused more leaking on the front of the tank (see Figure 39). The tank maintained its integrity. After the 30 minute exposure the bladder had sustained more damage. More of the bladder had become detached from the top rim and small holes were observed in the bladder material in the middle front where contact with the hot sheet metal had caused melting of the bladder. The metal sheets were blackened (see Figure 39). Water loss was estimated at 12 litres per minute.

Figure 39 Experiment 24 - pre-radiation and flame immersion on Bladder tank

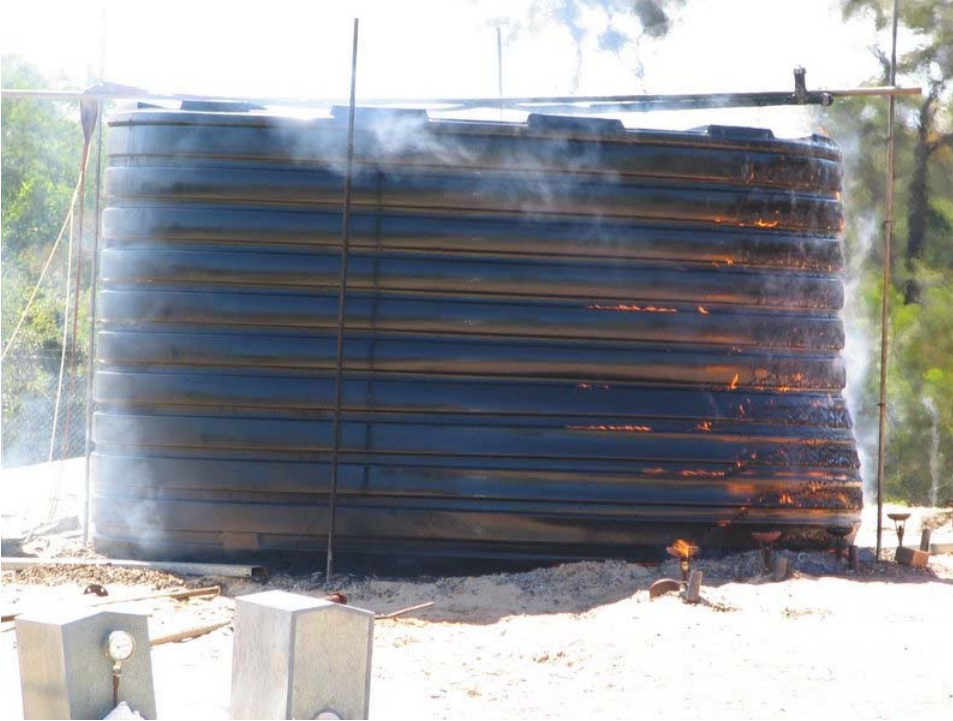
Smoke was observed from the burning leaf litter. After 8 minutes from the start of test the front of the tank was involved in flame from the middle to the top, 40 seconds later the entire front of the tank is involved in flame. 9 minutes after the start of test the tank showed some deformation at the bottom (slightly bulged). The flames on the front of the tank reduced when the burners were turned off (see Figure 41), after 9 minutes and 45 seconds the flaming ceased on the front surface. Flames were still observed on the edge and top of the tank. After 12 minutes significant leaks appeared from the top of the tank as the tank leant over towards the bulging side. This leakage occurred because the tank walls and top were manufactured as 2 separate mouldings and were screwed together resulting in a non-watertight joint. As the tank bulged and leant over the front rim of the tank and dipped below the water level.

**Figure 41 Experiment 25 - Leaf litter and pre-radiation exposure on used polyethylene tank**

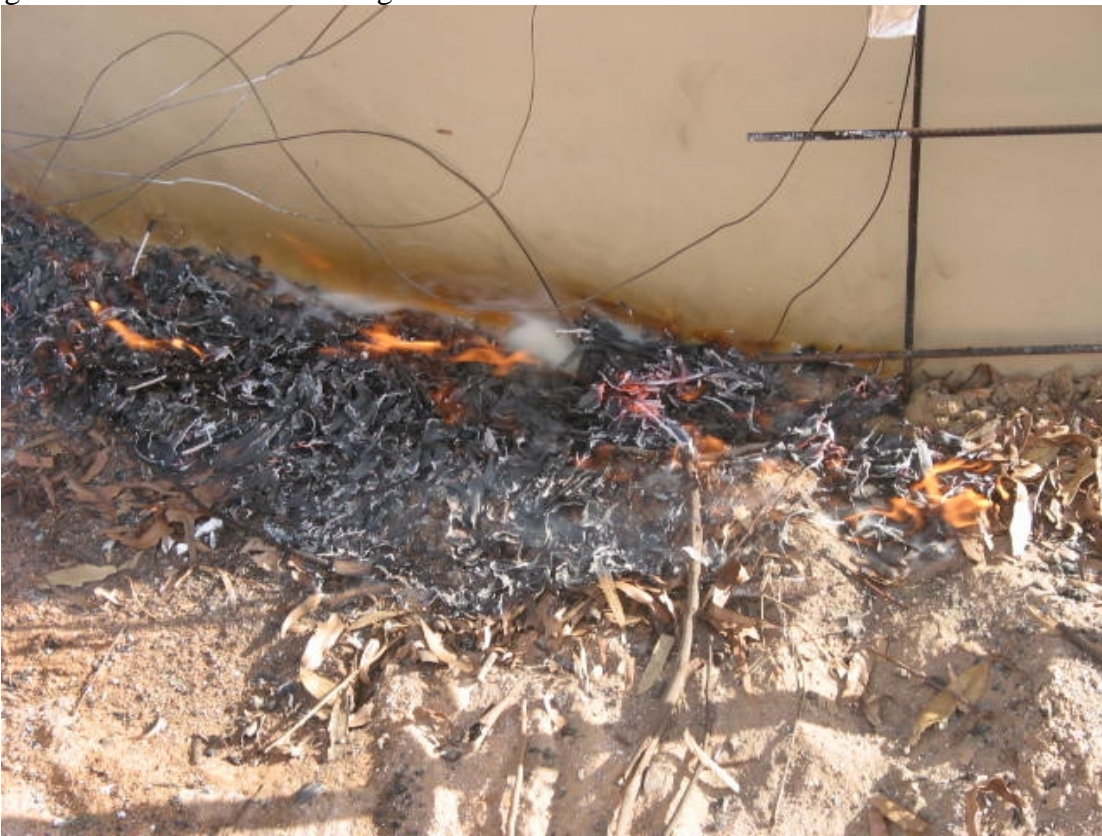
For leaf litter exposure the polyethylene tanks showed some involvement in the combustion process. In the worst case limited combustion ceased after 23 minute with no leakage occurring, persistence flame support for this period of time suggests that higher initial leaf litter loads may present a risk for water loss from the tank (experiment 18). Leaf litter exposure experiments on polyethylene water tank demonstrate they are unlikely to ignite and spread flame under this kind of exposure. Care should be taken not to allow large amounts of leaf litter or especial any heavy combustible fuels around the base of the tank.

Figure C8 Tank six smouldering litter contacting exterior of tank.

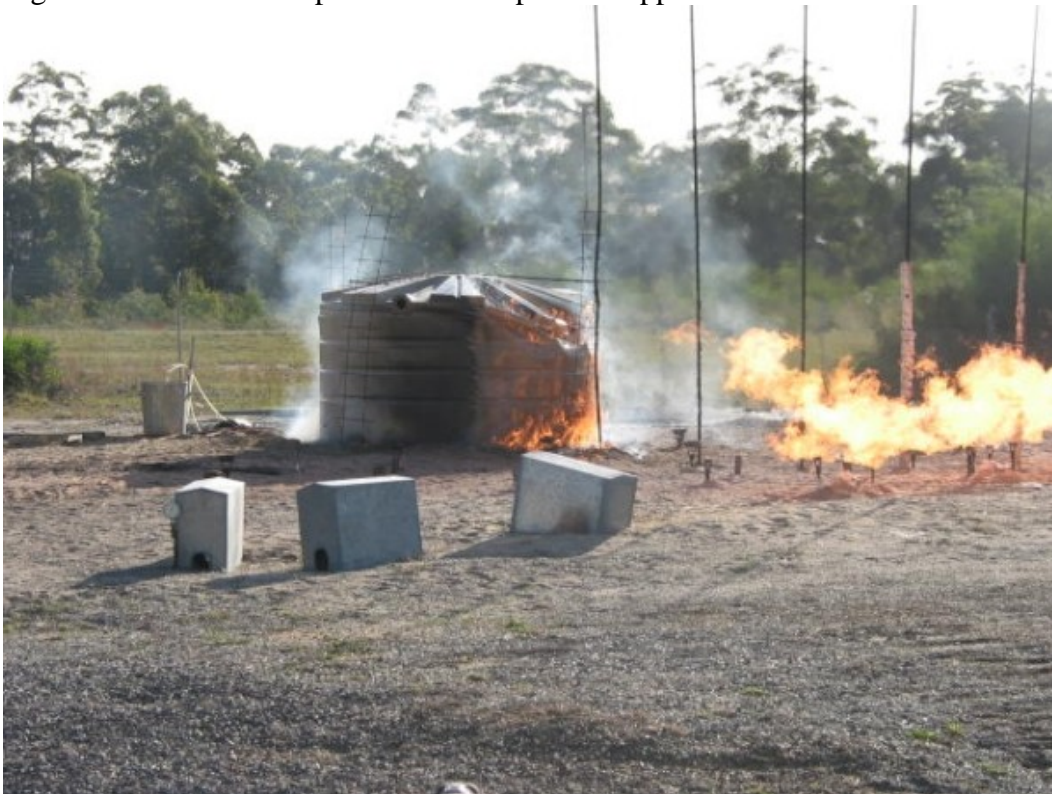
Radiation and ember exposures on polyethylene water tank show a significant degree of damage however all tanks maintained enough integrity to hold water. For many radiation exposures the tank portion above the waterline melted and was involved in flaming combustion. Flaming of the surface below the waterline was often observed. This flaming would cease as the radiation exposure was reduced.

Figure C10 Tank six ignition and flaming due to pre radiation exposure.

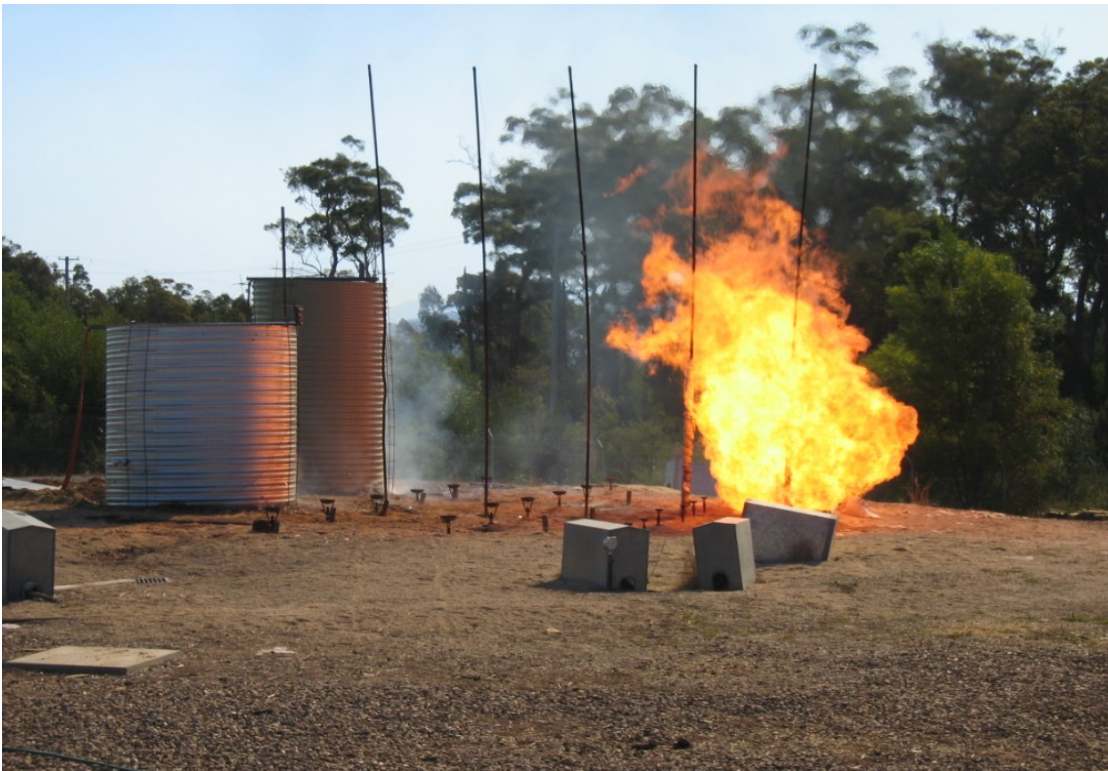
Figure C13 Tank three and five pre-radiation exposure.

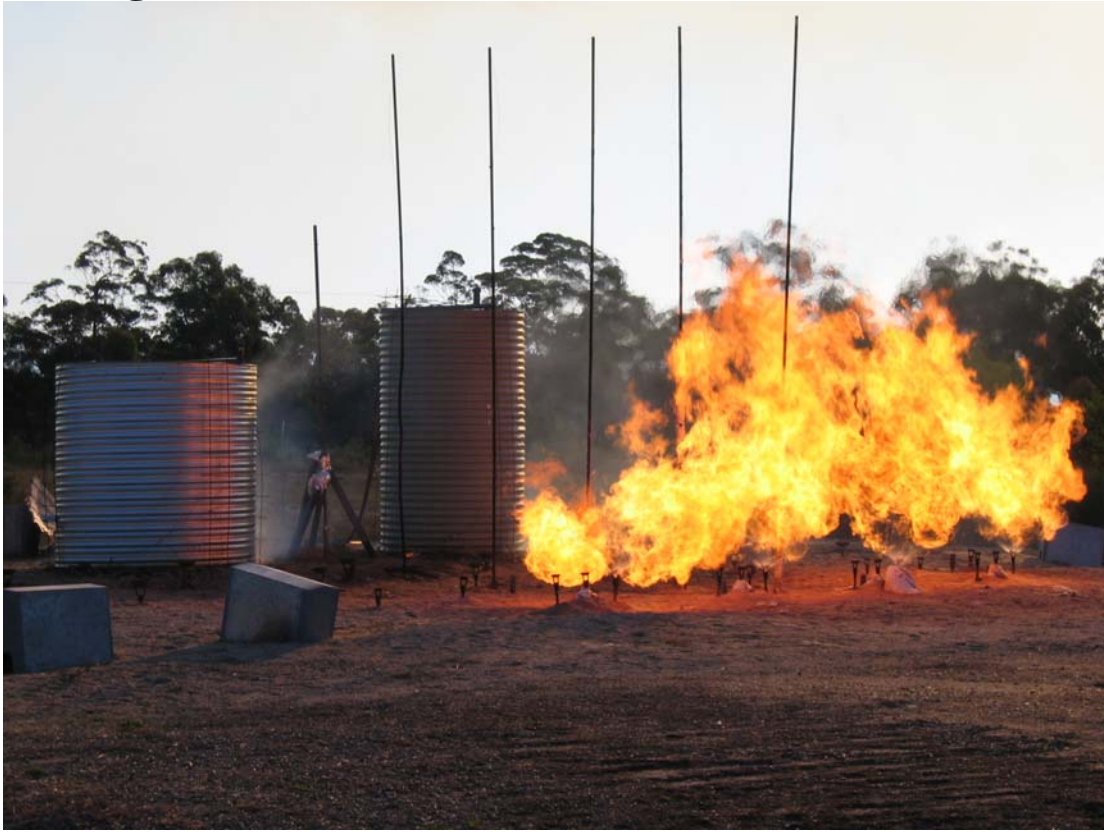
Figure C14 Tank three and five Pre Radiation exposure.

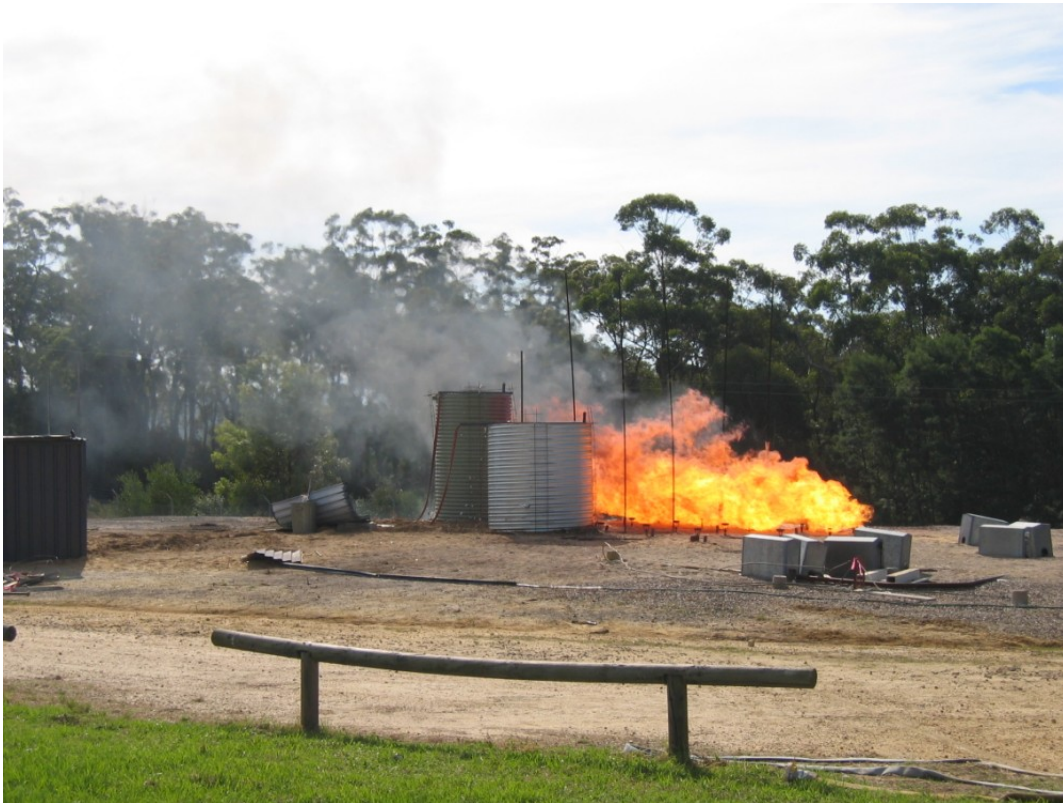
Figure C20 Tank three and five pre radiation exposure.

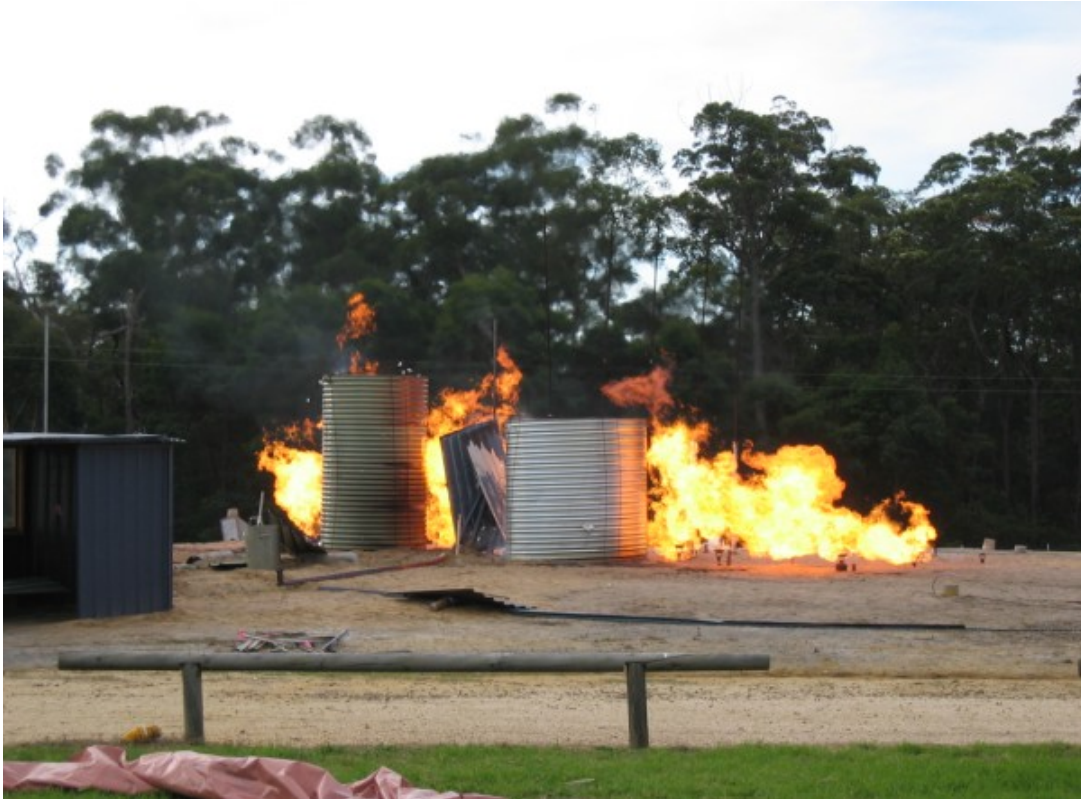
Figure C23 Tank three and five flame exposure.

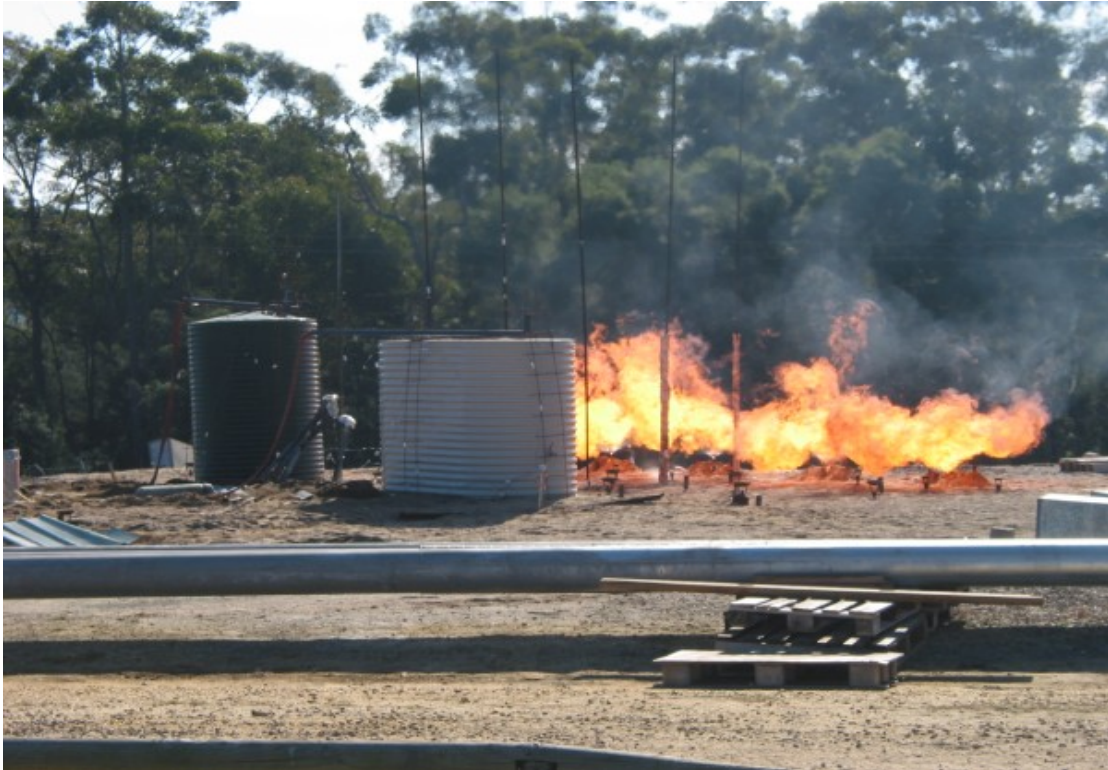
Figure C27 Tank two and four pre-radiation exposure.

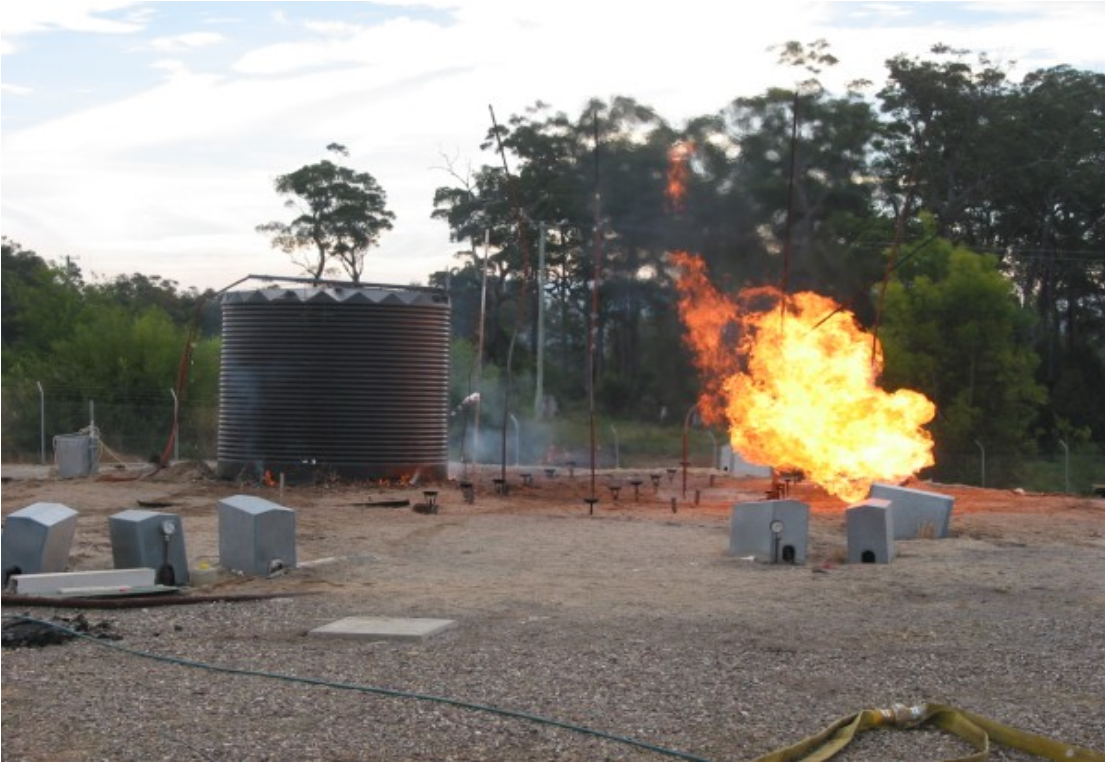
Figure C42 Tank 8 litter ignition and pre-radiation exposure.

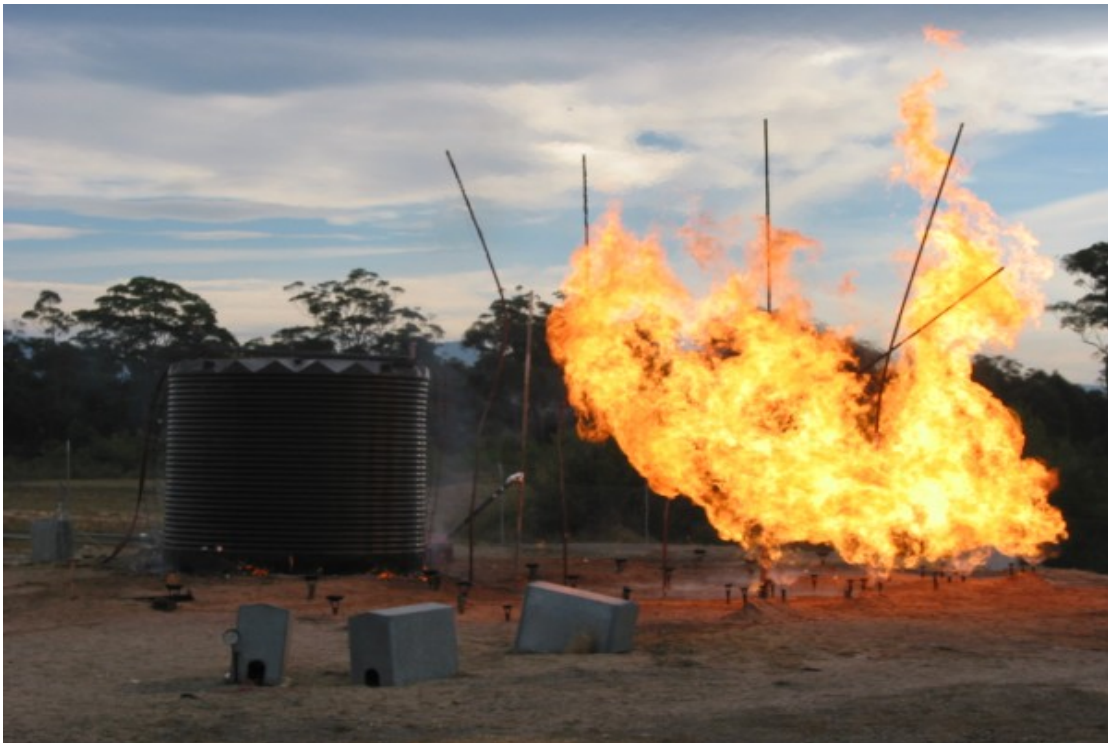
Figure C43 Tank 8 litter ignition and pre-radiation exposure.

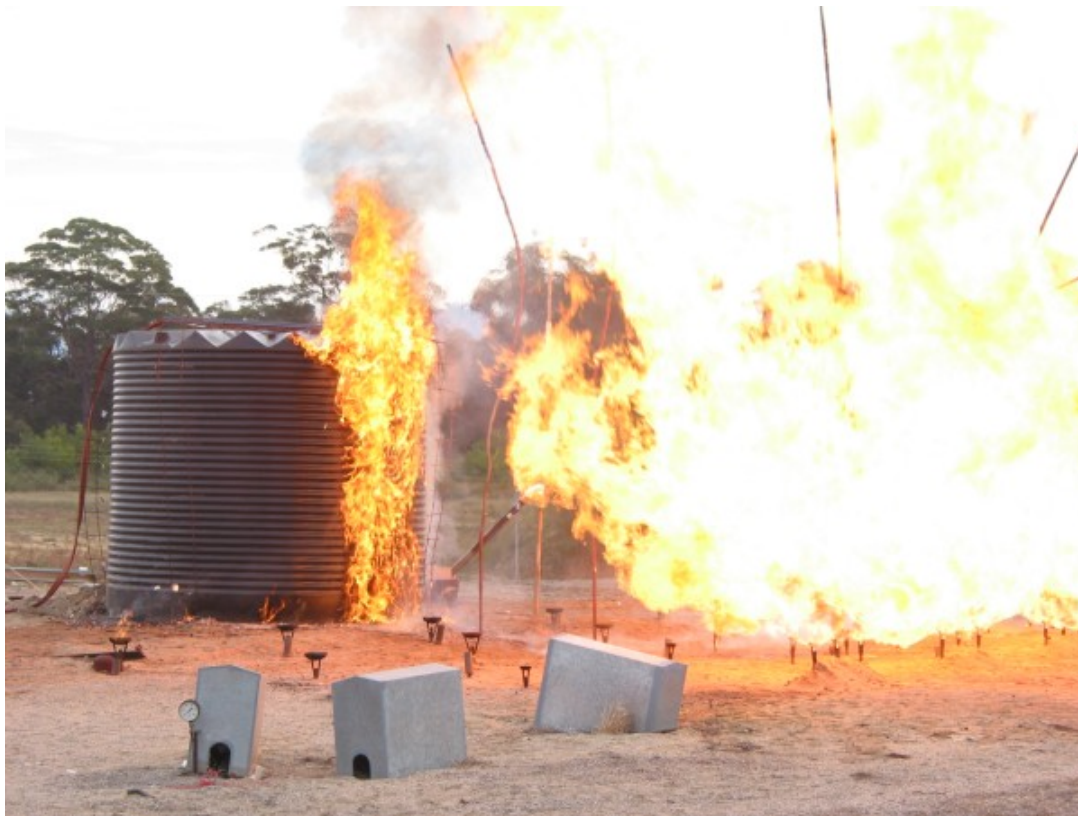
Figure C44 Tank 8 ignition as a result of litter ignition and pre-radiation exposure.

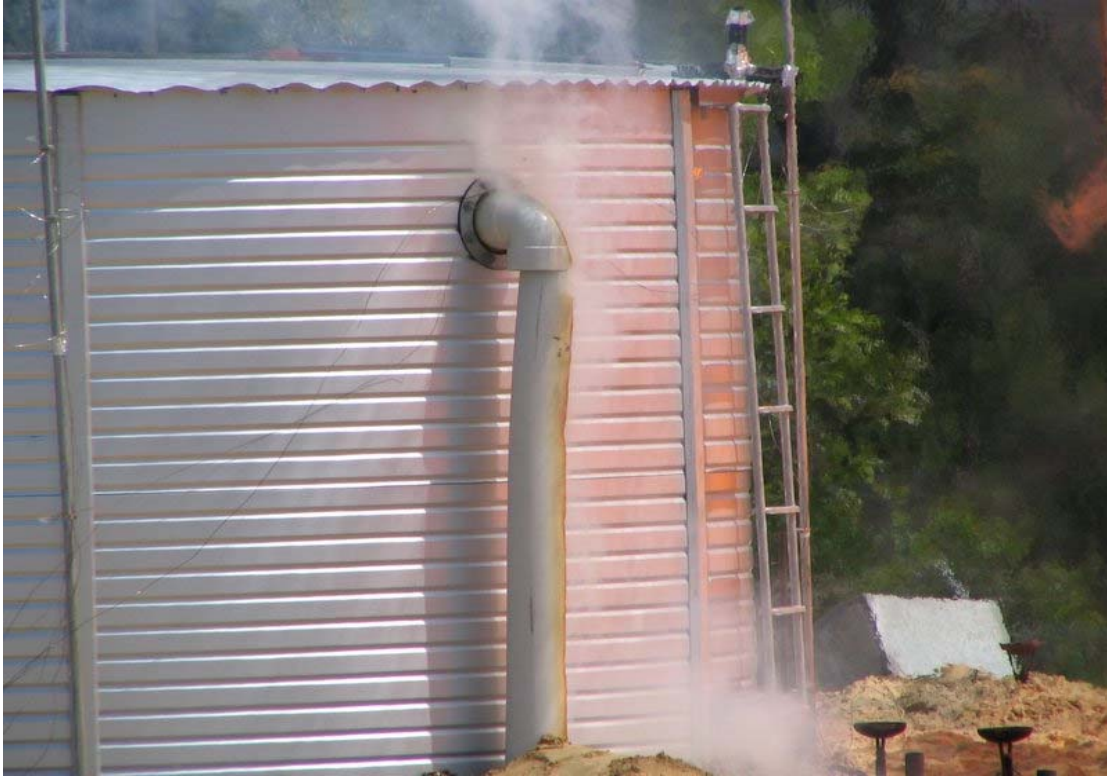
Figure C56 Bladder tank pre-radiation exposure.

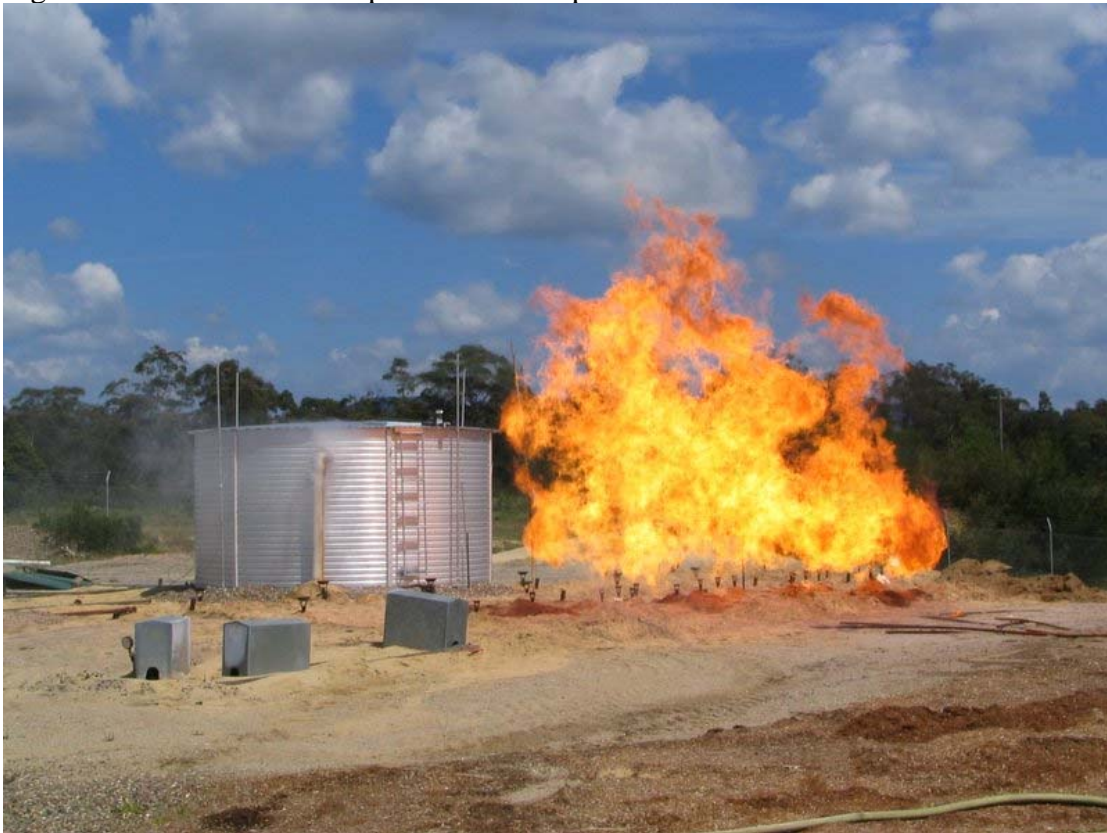
Figure C57 Bladder tank pre-radiation exposure.

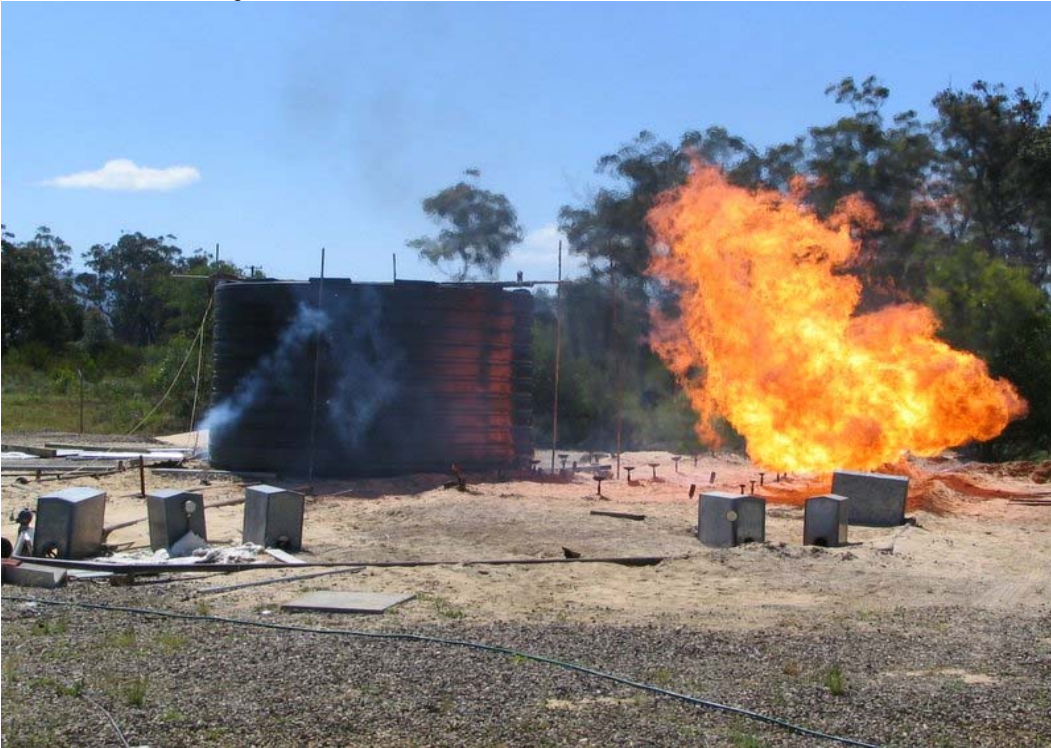
Figure C68 Tank 10 litter ignition and pre-radiation exposure.

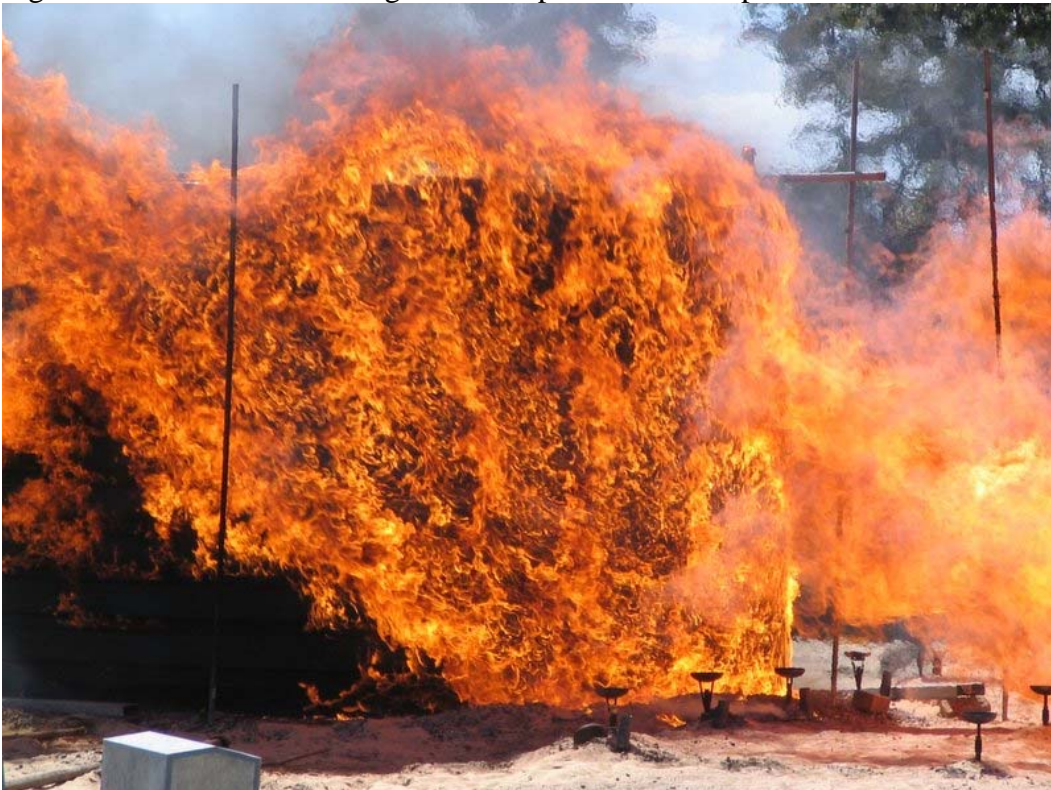
Figure C69 Ignition of tank 10 during the litter ignition and pre-radiation exposure.

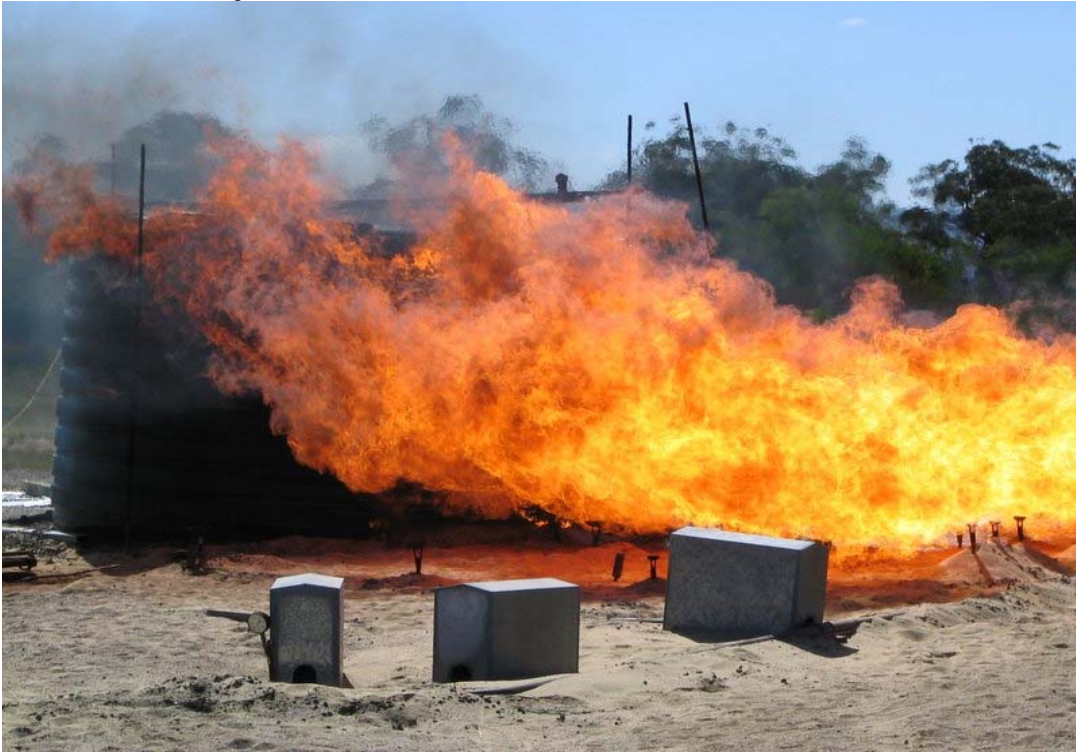
Figure C72 Tank 10 litter ignition, pre-radiation and flame exposure.
